Our Mistakes
Reforming Unit
LV-2016

Problem

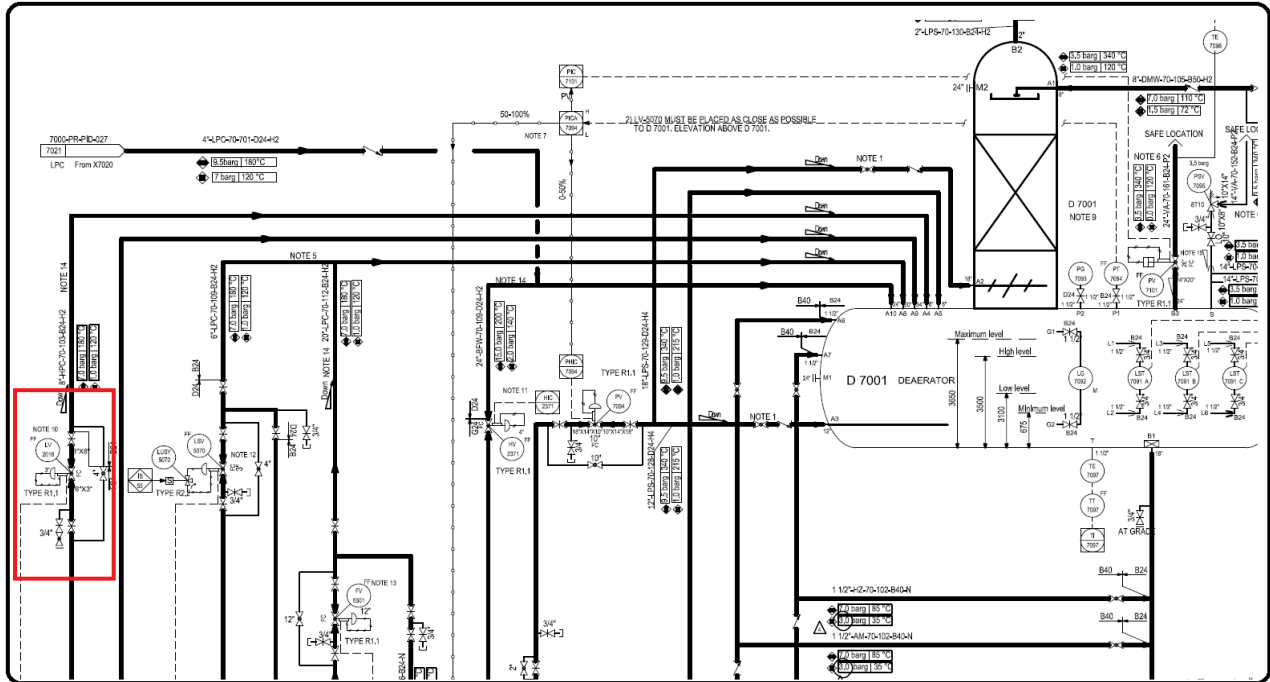
P&ID

Even though the material was suitable for the application we observed severe corrosion in the control valve.

Lack of experience which led to wrong installation of control valve.

Creation of jetting steam which corrodes the body of the valve.

There is no need to change the material if already suitable based on convention. You just need to change the direction.
