TIANCHEN CORP. CHINA	Project :	MKP Methanol Project			Owner :

شرکت کیمیای پارس خاورمیانه Middle East Kumiya Pars Co.
	Unit	General Technical	Phase	Detail Engineering	
	Doc. Title :	PACKAGE HAZOP			
Vendor :

PACKAGE HAZOP

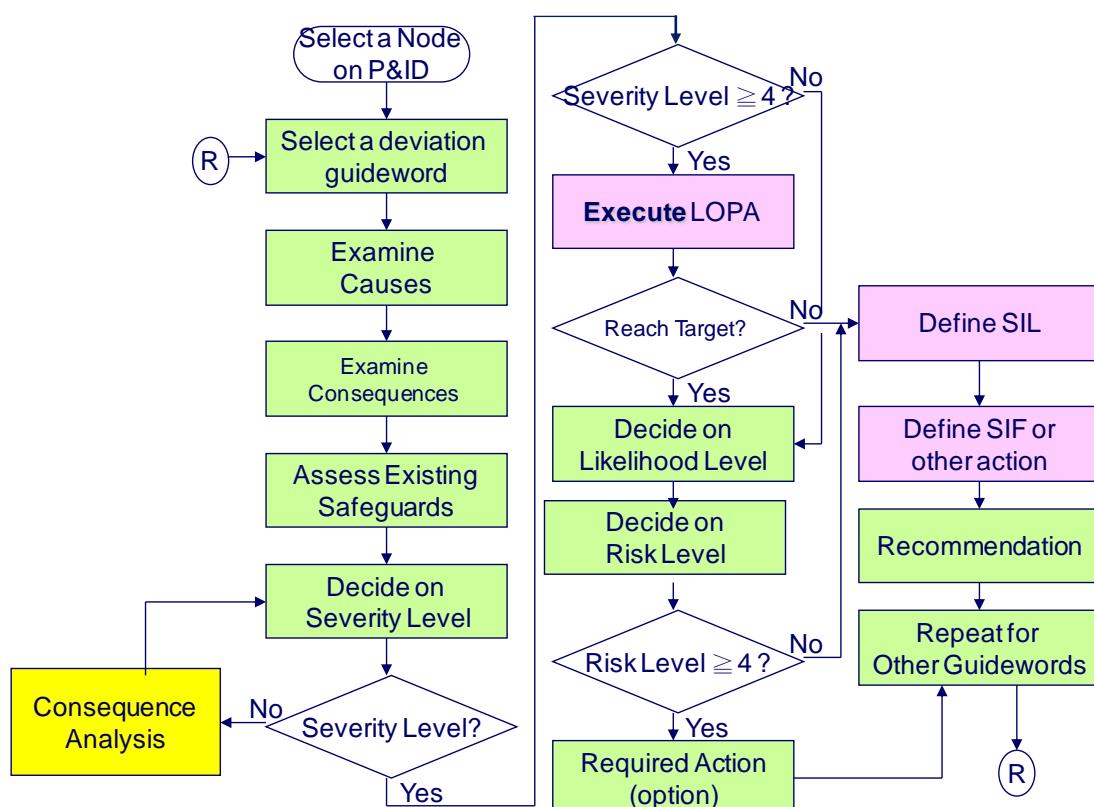
Figure 1 HAZOP/LOPA Assessment Workflow

Proceed to determine the required SIL for the safety instrumented function (SIF) or other risk prevention or mitigation measures with a PFD that is equivalent to this SIL, and provide safety improvement recommendations. HAZOP and LOPA assessment workflow is depicted below in figure 1

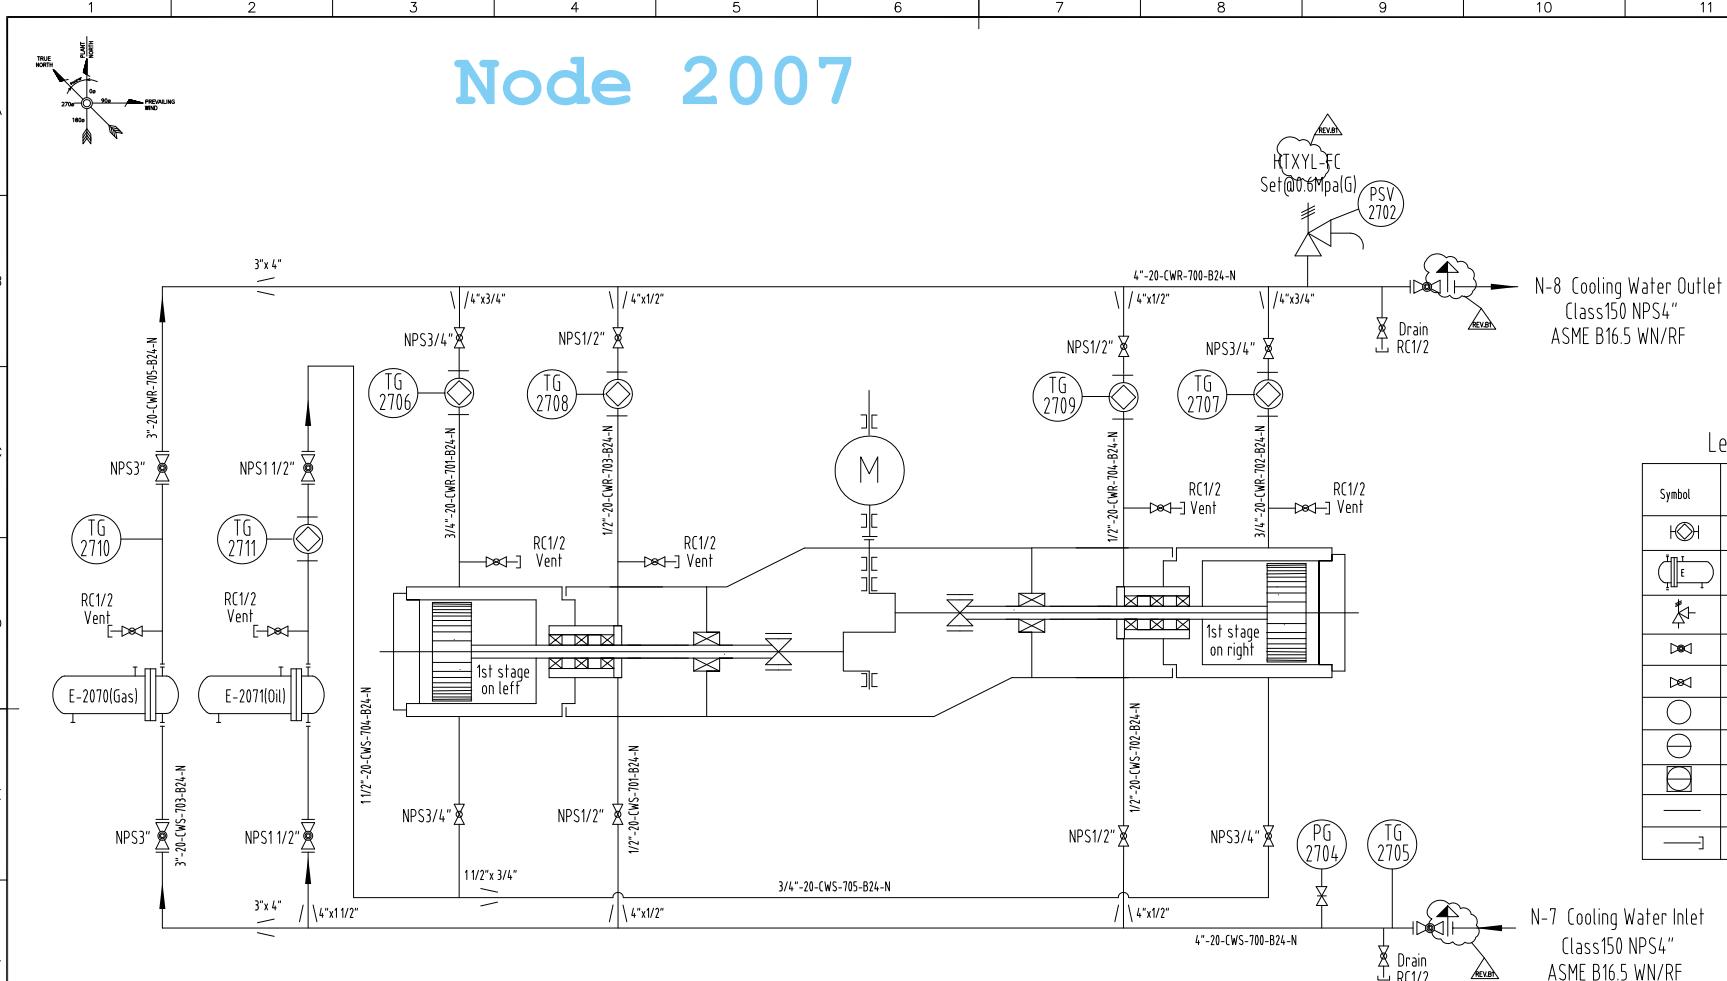
Node 2007

REV.	PURPOSE OF ISSUE	DATE	DESIGN	DRAW	CHECK	REVIEW	APPROVE
OWNER: Middle East Kimia Pars Company							
LICENDEE: HALDOR TOPSOE A/S							
CONTRACTOR DRAWING NO. TCC CHINA TIANCHEN ENGINEERING CORPORATION							
SHEET 1 TOTAL 1 SUB-CONTRACTOR DRAWING NO. 206.5(Y95).00							
PROJECT MKP Methanol Project UNIT REFORMER PHASE DETAILED ENGINEERING							
SCALE 1:1 SHEET:1 TOT:1 SIZE:1 OWNER DWG NO. MKP-VD-9000-306-005-A1

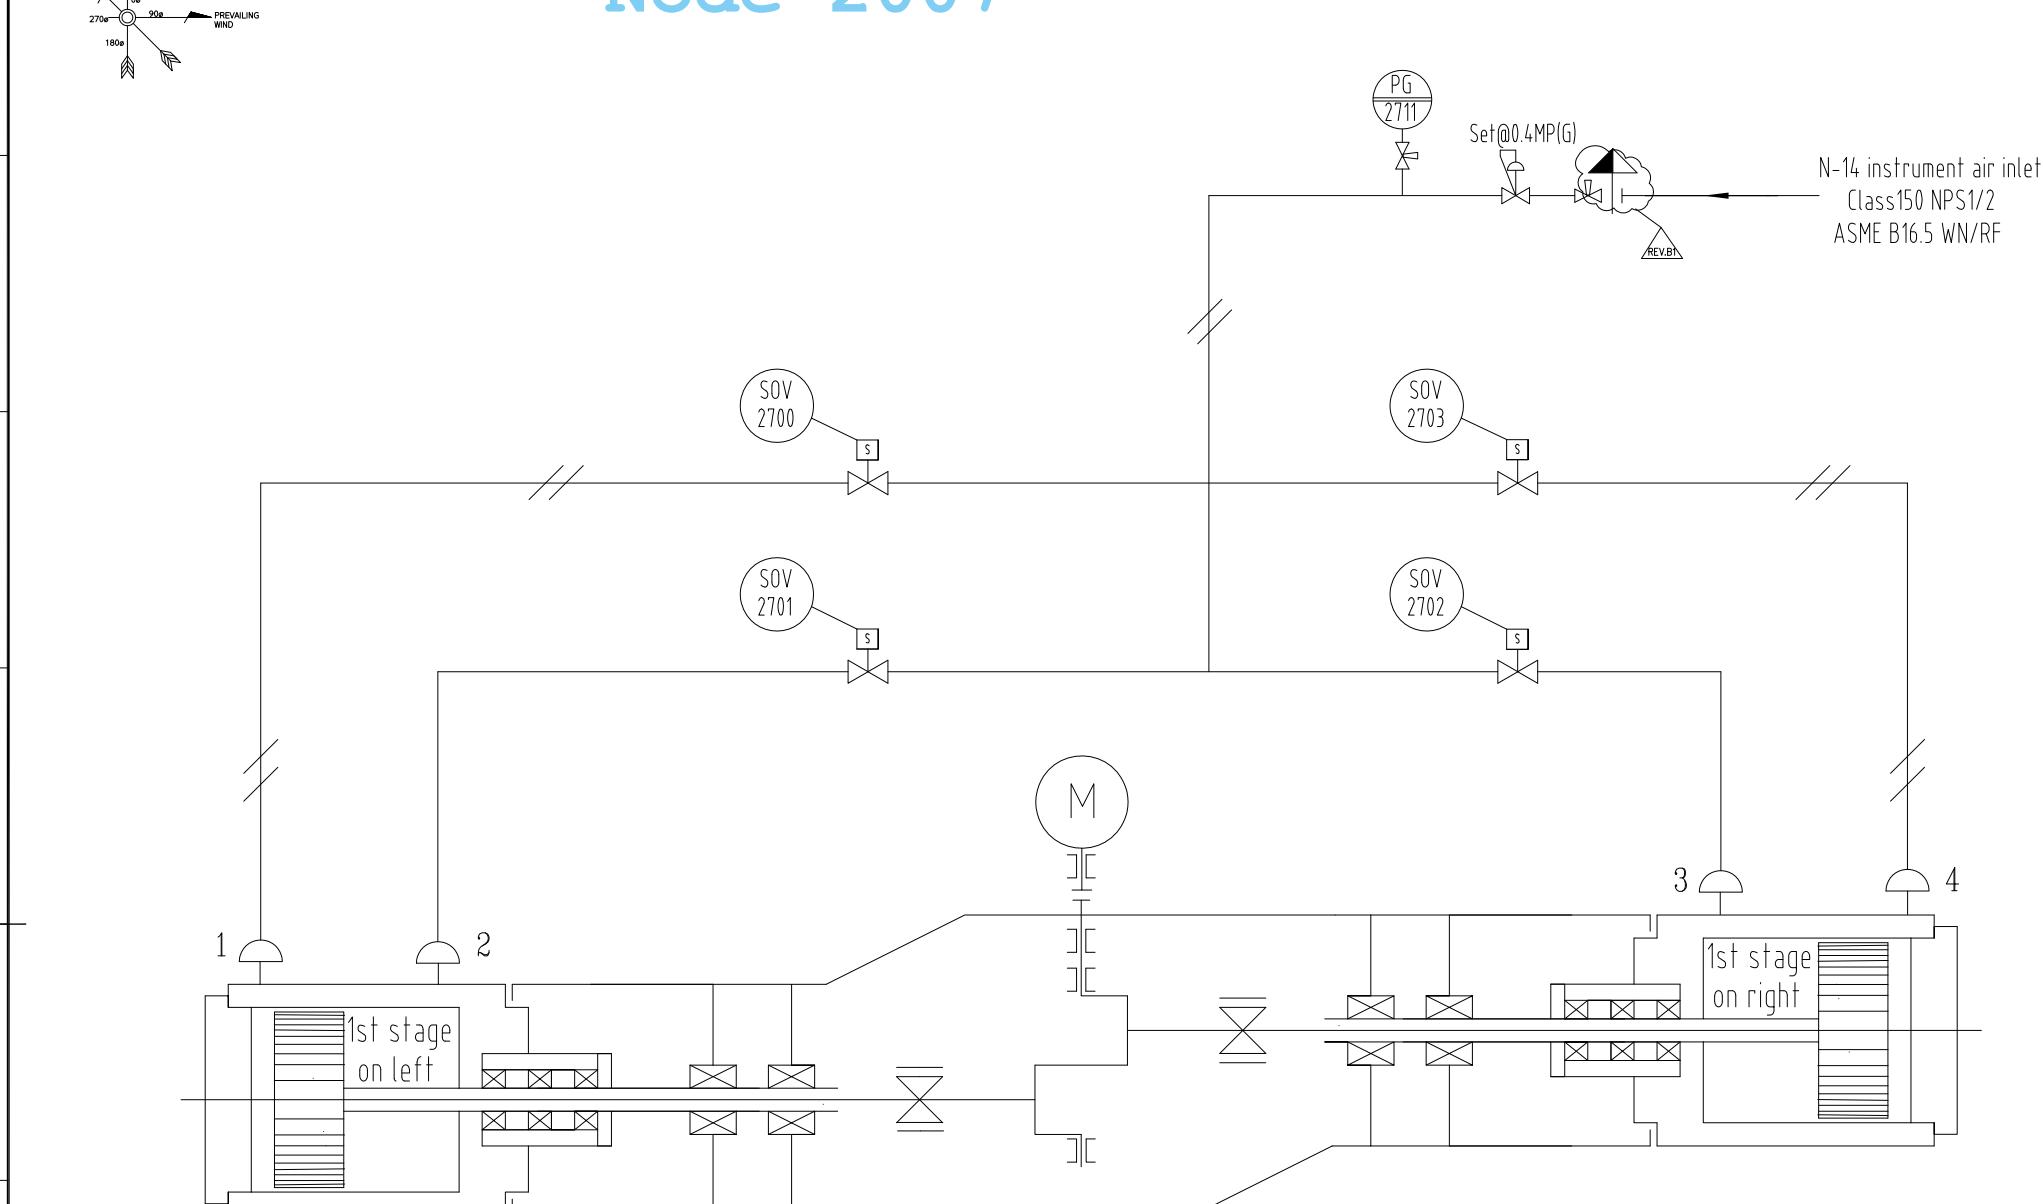
Node 2007

Capacity Control Method								
Stage	1st stage on left		1st stage on right		solenoid valve			
Capacity	HE-1	CE-2	HE-4	CE-3	SOV-2700	SOV-2701	SOV-2702	SOV-2703
0%	NA	NA	NA	NA	E	E	E	E
25%	NA	A	NA	NA	E	DE	E	E
50%	NA	A	NA	A	E	DE	DE	E
75%	NA	A	A	A	E	DE	DE	DE
100%	A	A	A	A	DE	DE	DE	DE

C-Close NA-No Acting HE-Head End DE-De Energized

O-Open A-Acting CE-Crank End E-Energized

. 4	incorrect flow direction	1 non actual hazard identify						N	
. 5	reverse flow	1 Capacity control valves (suction valves) failure.	Temperature increase, and damage piston ring,rider ring and packing ring.	1.TIA-2701/2703 high temperature alarm, and high high temperature alarm. 2.Check valve at C-2002 outlet.	3	4	3	N	TIA-2701/2703 add high high temperature trip.
. 6	part of flow/composition	1 non actual hazard identify						N

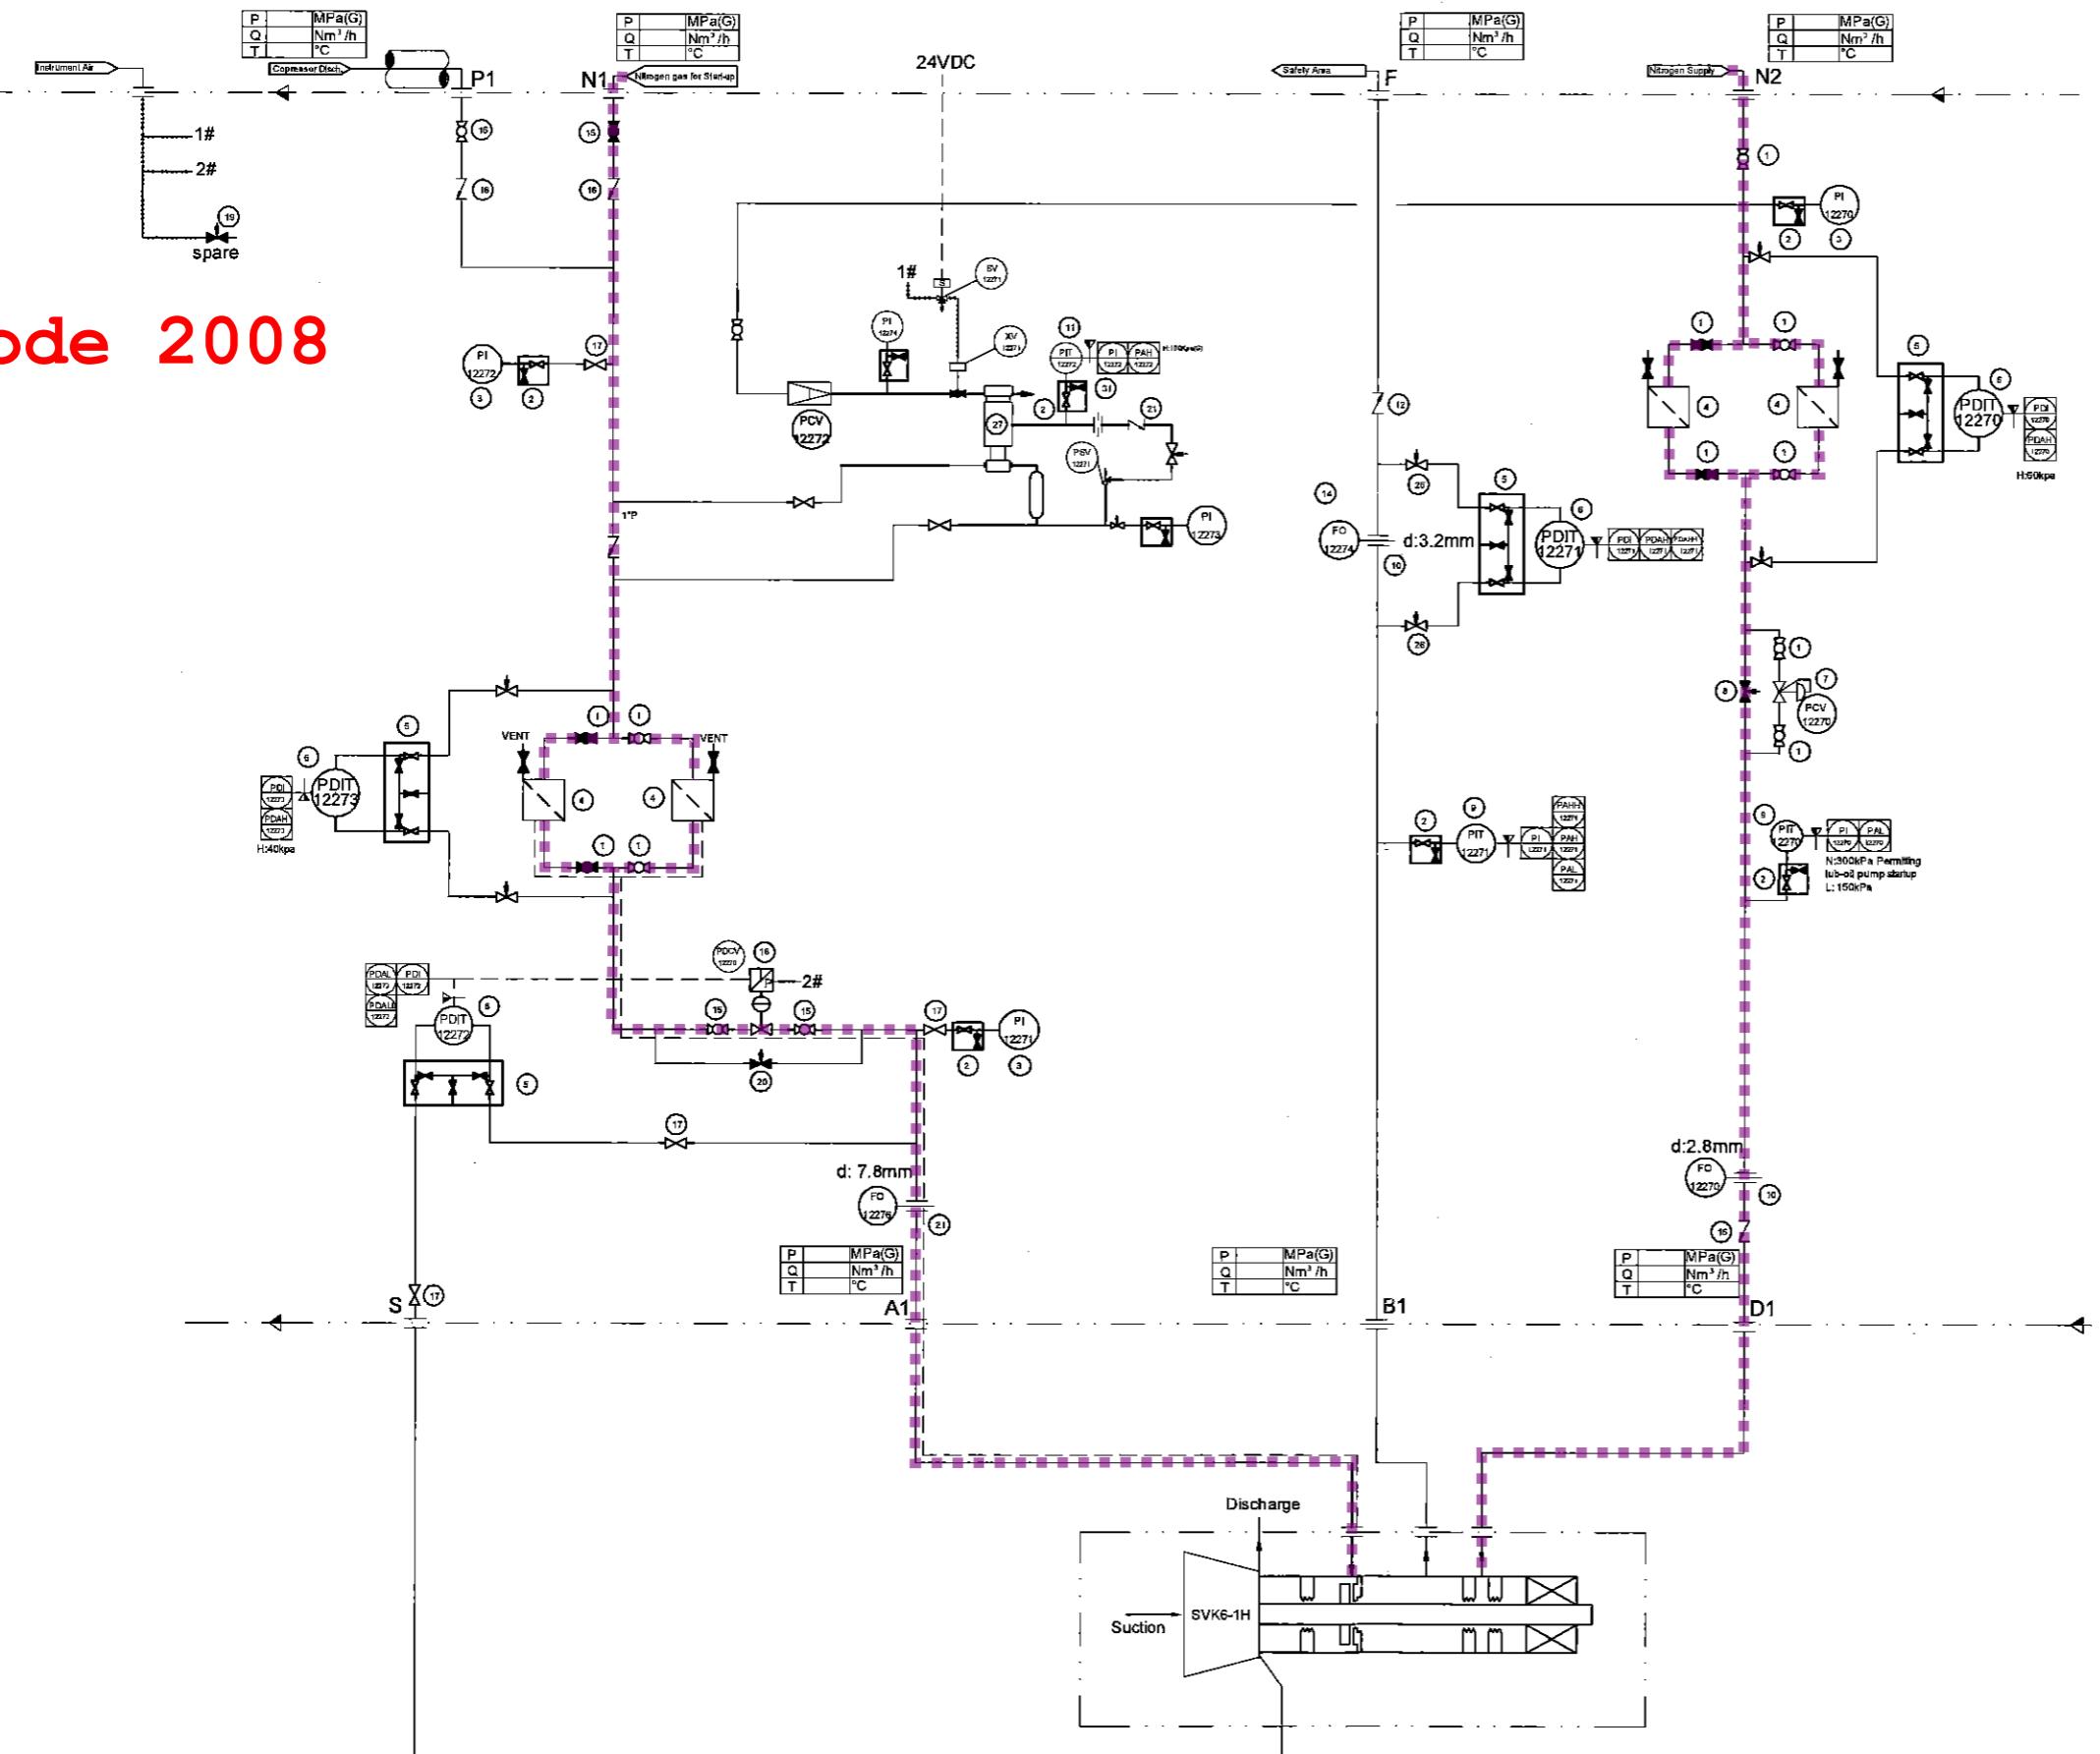
Project	IRAN ME PROJECT						Name	Date	APPD.	REV.D1
Customer	MEKPCO						Drawn	WB	2016.09.30	
Site	ASSALUYEH						Checked			
Compressor	SV6-M						Appd.			
Item No.	C-2001						Scale	P&I DIAGRAM SEAL MANAGEMENT SYSTEM		
Dry Gas Seal	Single Seals						NTS			
							Drawing No.	0541-JA16704-PID	Actual Wt./Ref No.	
							Originated from	Replacement for	Replaced by	CAI

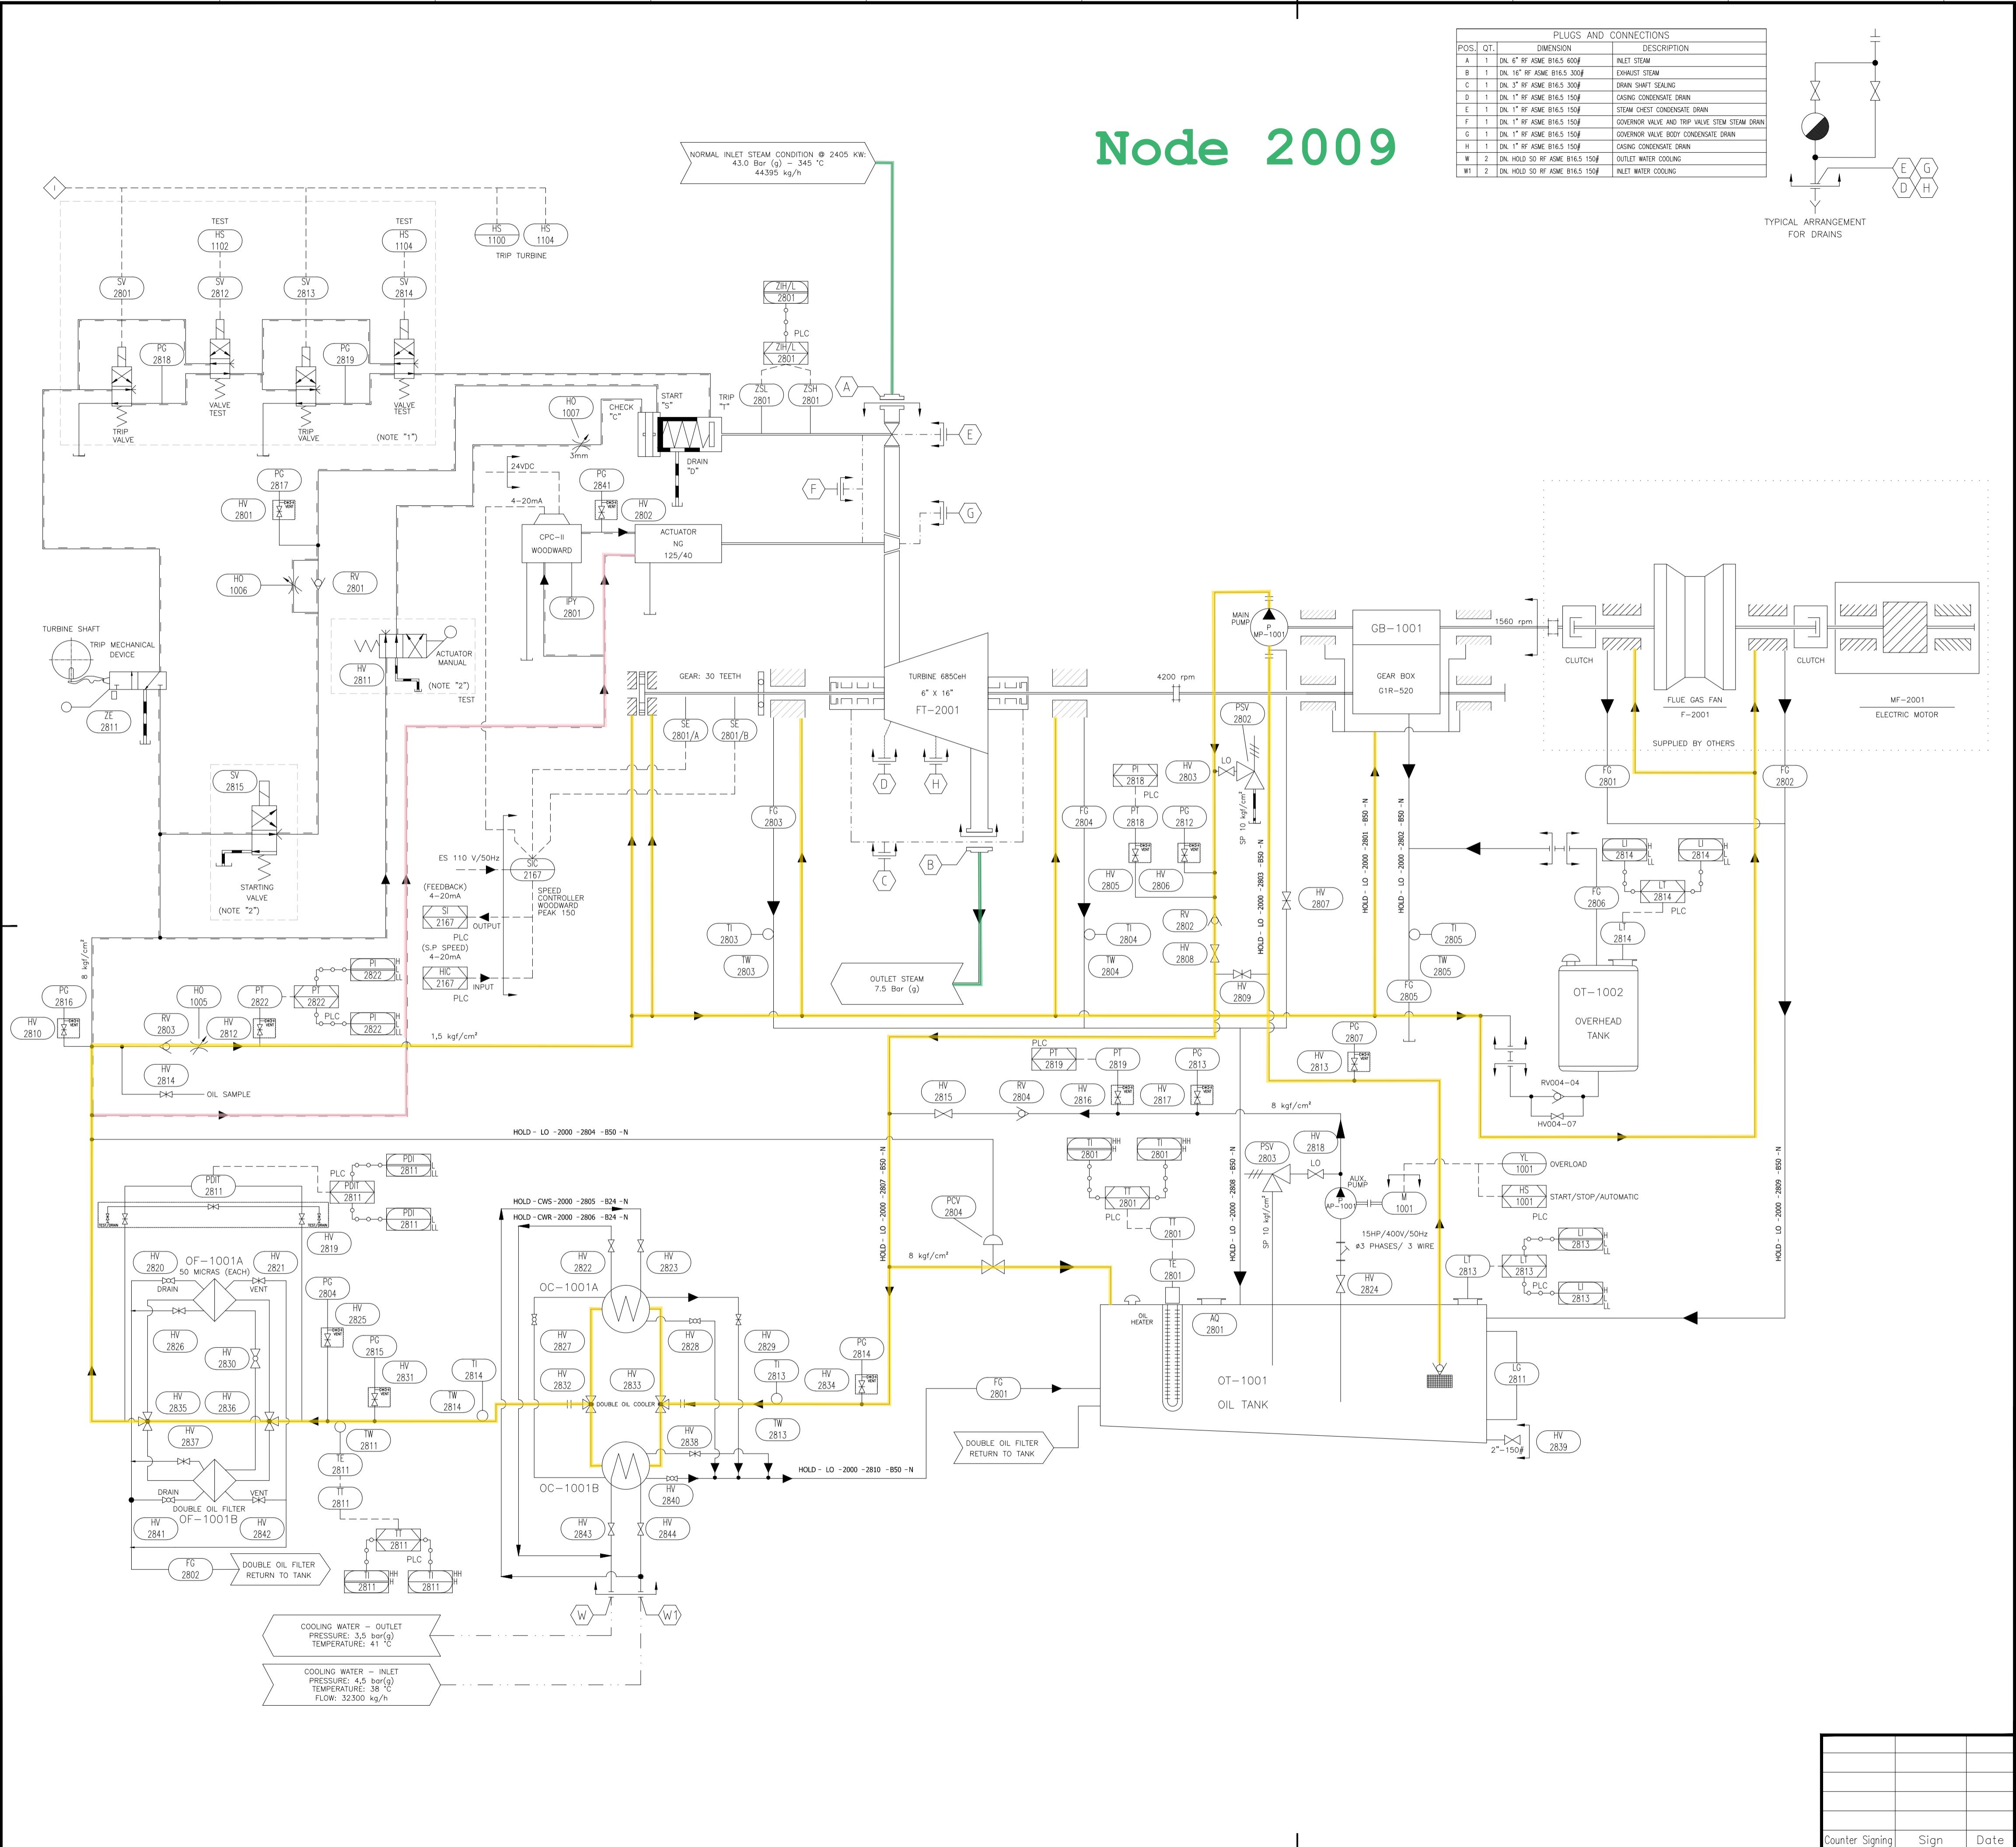
Node 2009

1 - VALVES SV-2801, SV-2802, SV-2803 AND SV-2804 FORM A SINGLE MANIFOLD BLOCK;
2 - VALVES HV-2803 AND SV-2805 FORM A SINGLE MANIFOLD BLOCK;
3 - CONNECTIONS D, E, G, H, SHOULD BE DRAINED TO AN ATMOSPHERIC COLLECTOR (PIPING) SUPPLIED BY CLIENT.

TCC CHINA TIANCHEN ENGINEERING CORPORATION						
VENDOR DRAWING NO.							
I.T.T. SpA - Milano - Italy							
PROCESS INSTRUMENTATION DIAGRAM	PROJECT	MKP Methanol Project					
TURBINE: 685 CeH	UNIT	PRIMARY REFORMER PACKAGE (H 2001)					
CUSTOMER: MKP - IRAN	PHASE	DETAIL ENGINEERING					
SCALE N/S	Sheet	03	TOT.	05	SIZE	A1	OWNER DWG NO.
							MKP-VD-2000-351-145-A1

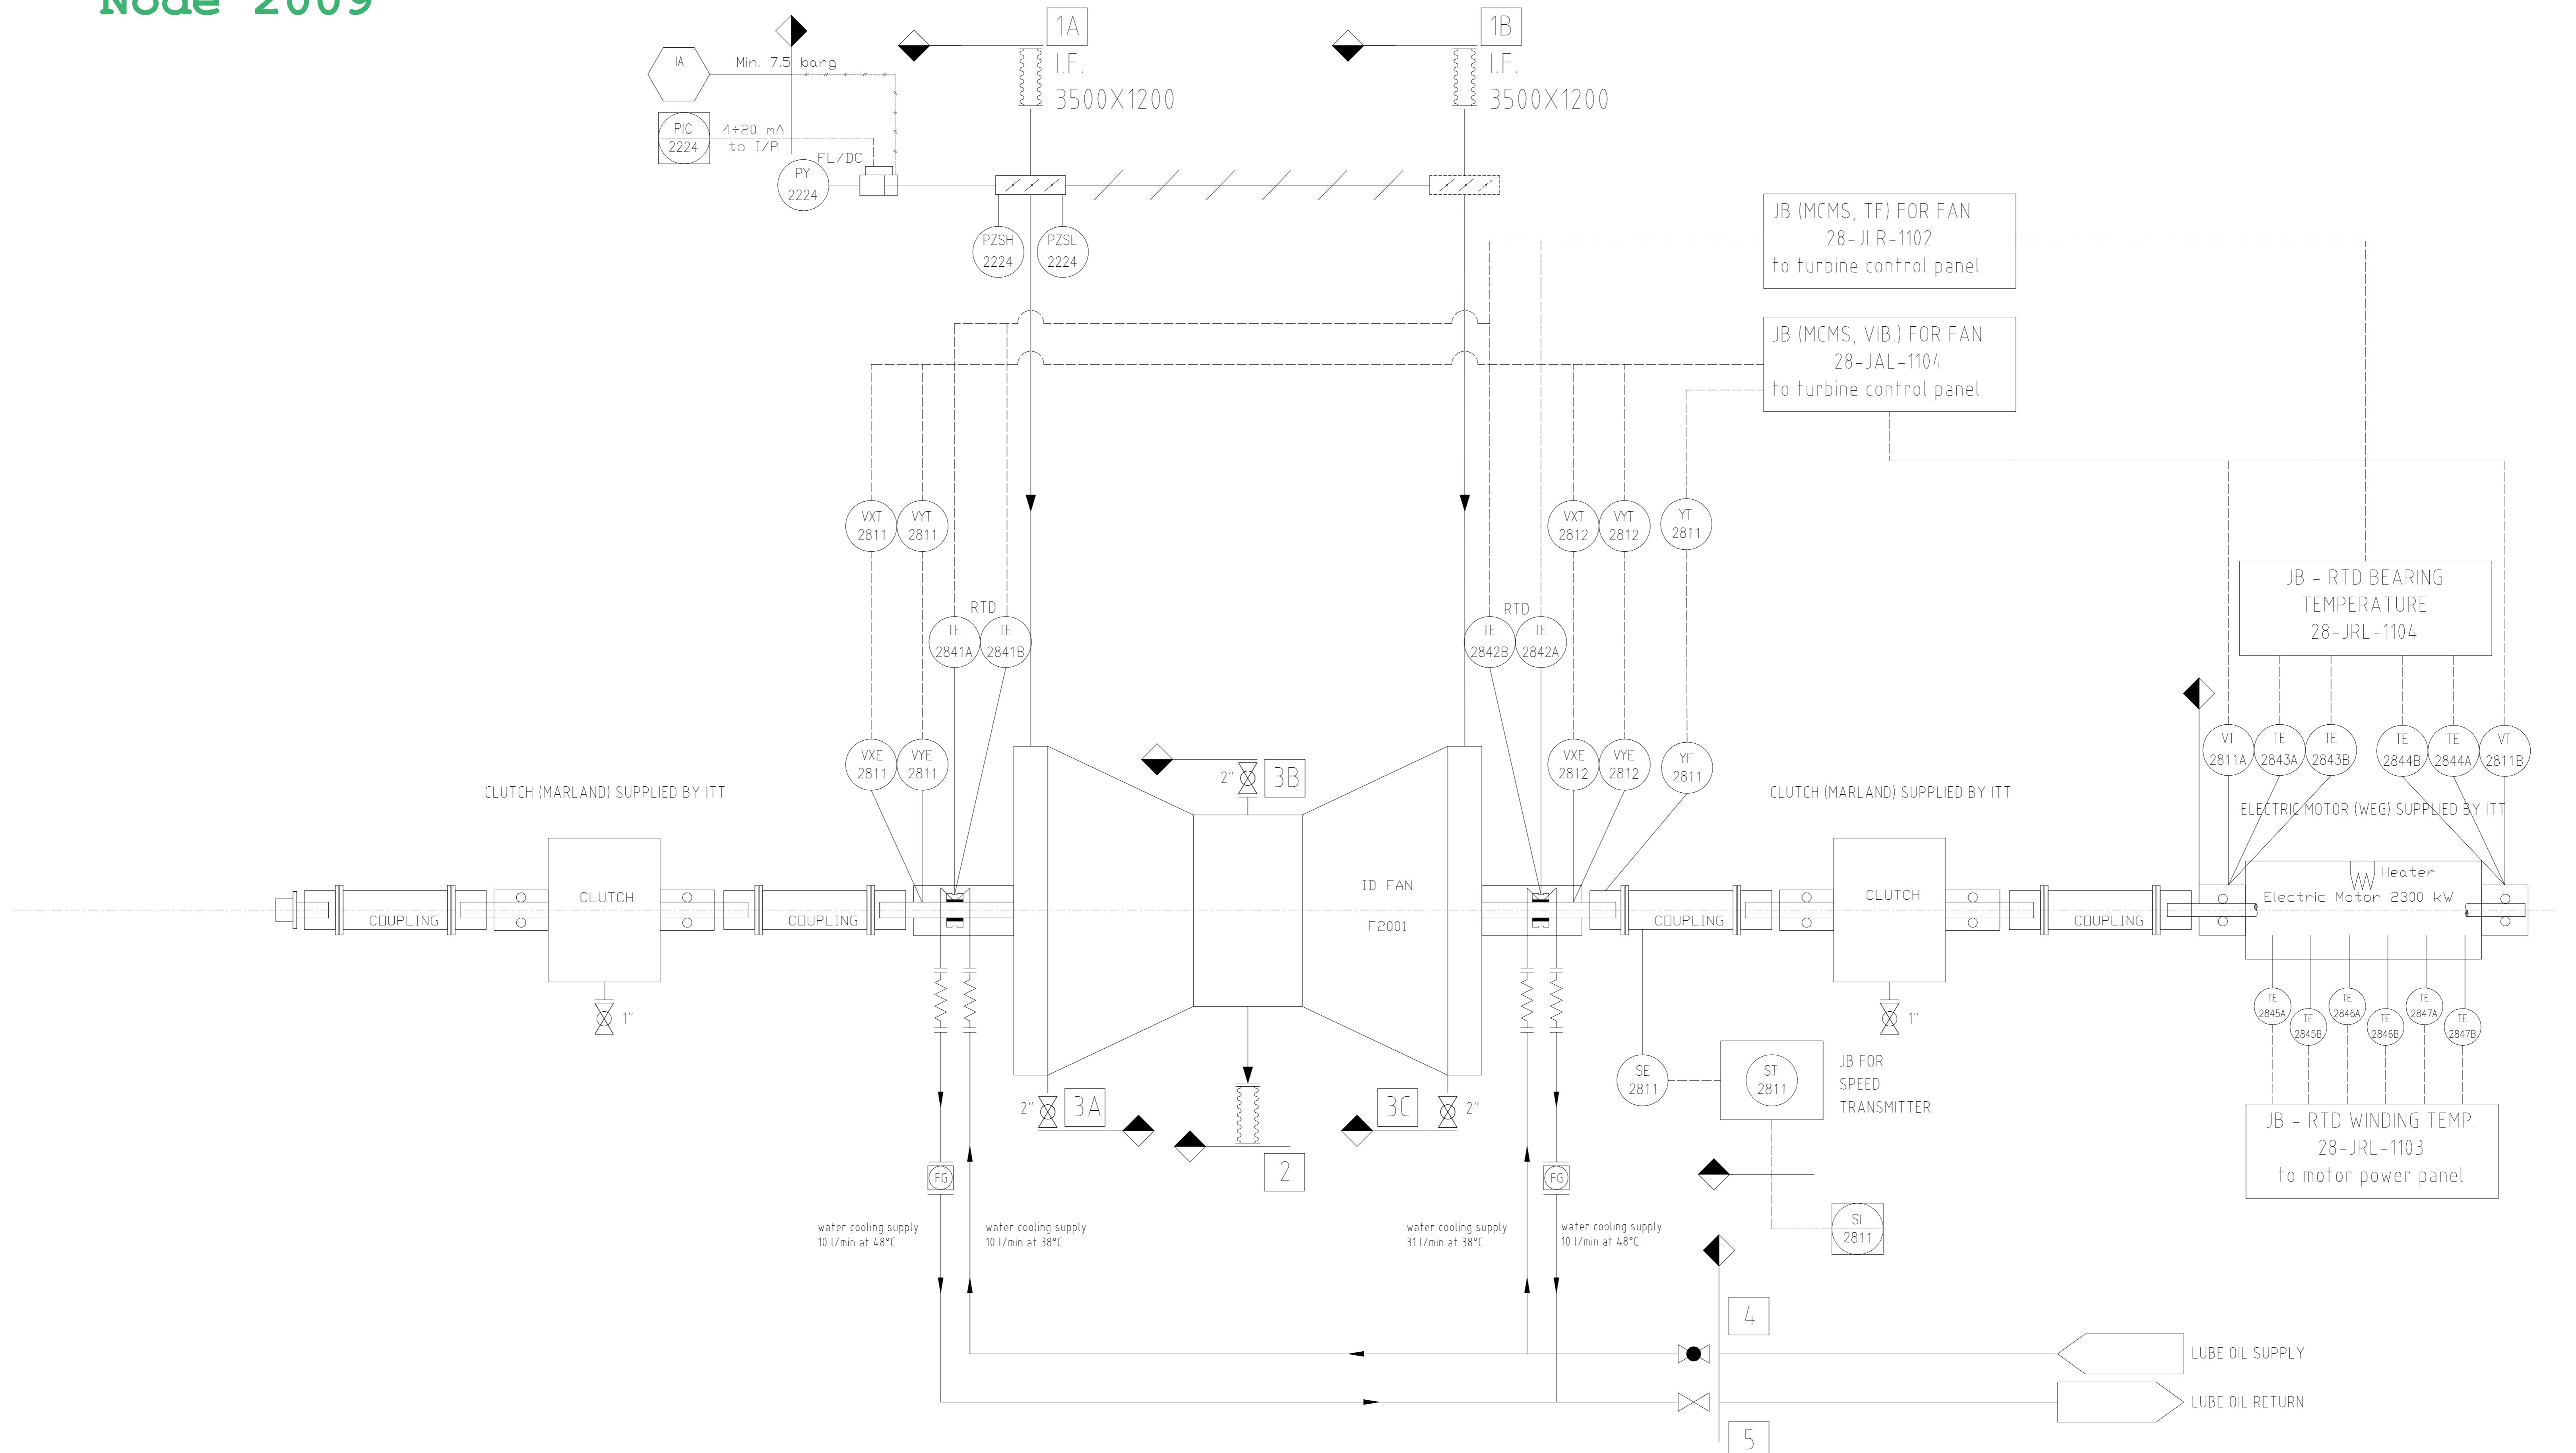
Node 2009

LEGENDA	
MECHANICAL LINK	WATER COOLING LINE
WATER COOLING LINE	Flexible pipe for adjustments
PNEUMATIC SIGNAL LINE	FLOW GLASS
OIL PIPING	FIELD INSTRUMENT
STEAM PIPING	MAIN CONTROL ROOM INSTRUMENT
INSTRUMENT CAPILLARY TUBING	REMOTE/LOCAL PANEL - MOUNTED INSTRUMENT
SOFTWARE LINK	DCS BY CUSTOMER
ELECTRICAL SIGNAL LEAD	INTERLOCK IN CUSTOMER ESD
BALL VALVE	
GLOBE VALVE	
GATE VALVE	
CHECK VALVE	
SAFETY VALVE	
A) ALL OIL PIPING STAINLESS STEEL AISI 316L SCH 40	
B) ALL TUBING AND FITTINGS STAINLESS STEEL AISI 317L

SE = SPEED PROBE
 VXE = VIBRATION SENSOR AXIS X
 VYE = VIBRATION SENSOR AXIS Y
 YE = KEY PHASOR SENSOR
 VT = VELOMOTOR SENSOR

TCC CHINA TIANJIN ENGINEERING CORPORATION	PROJECT MKP Methanol Project	UNIT PRIMARY REFORMER	PHASE DETAIL ENGINEERING	P&ID FOR_FAN_(F-2001)		
				151048-PID-001	OWNER DWG NO. MKP-VD-2000-351-302-A0	
CONTRACTOR HALDOR TOPSØE A/S						
CONTRACTOR I.T.T. SpA - Milano - Italy						
Counter Signing	Sign	Date				
SCALE 1:50	HEET 01	TOT. 01	SIZE A0

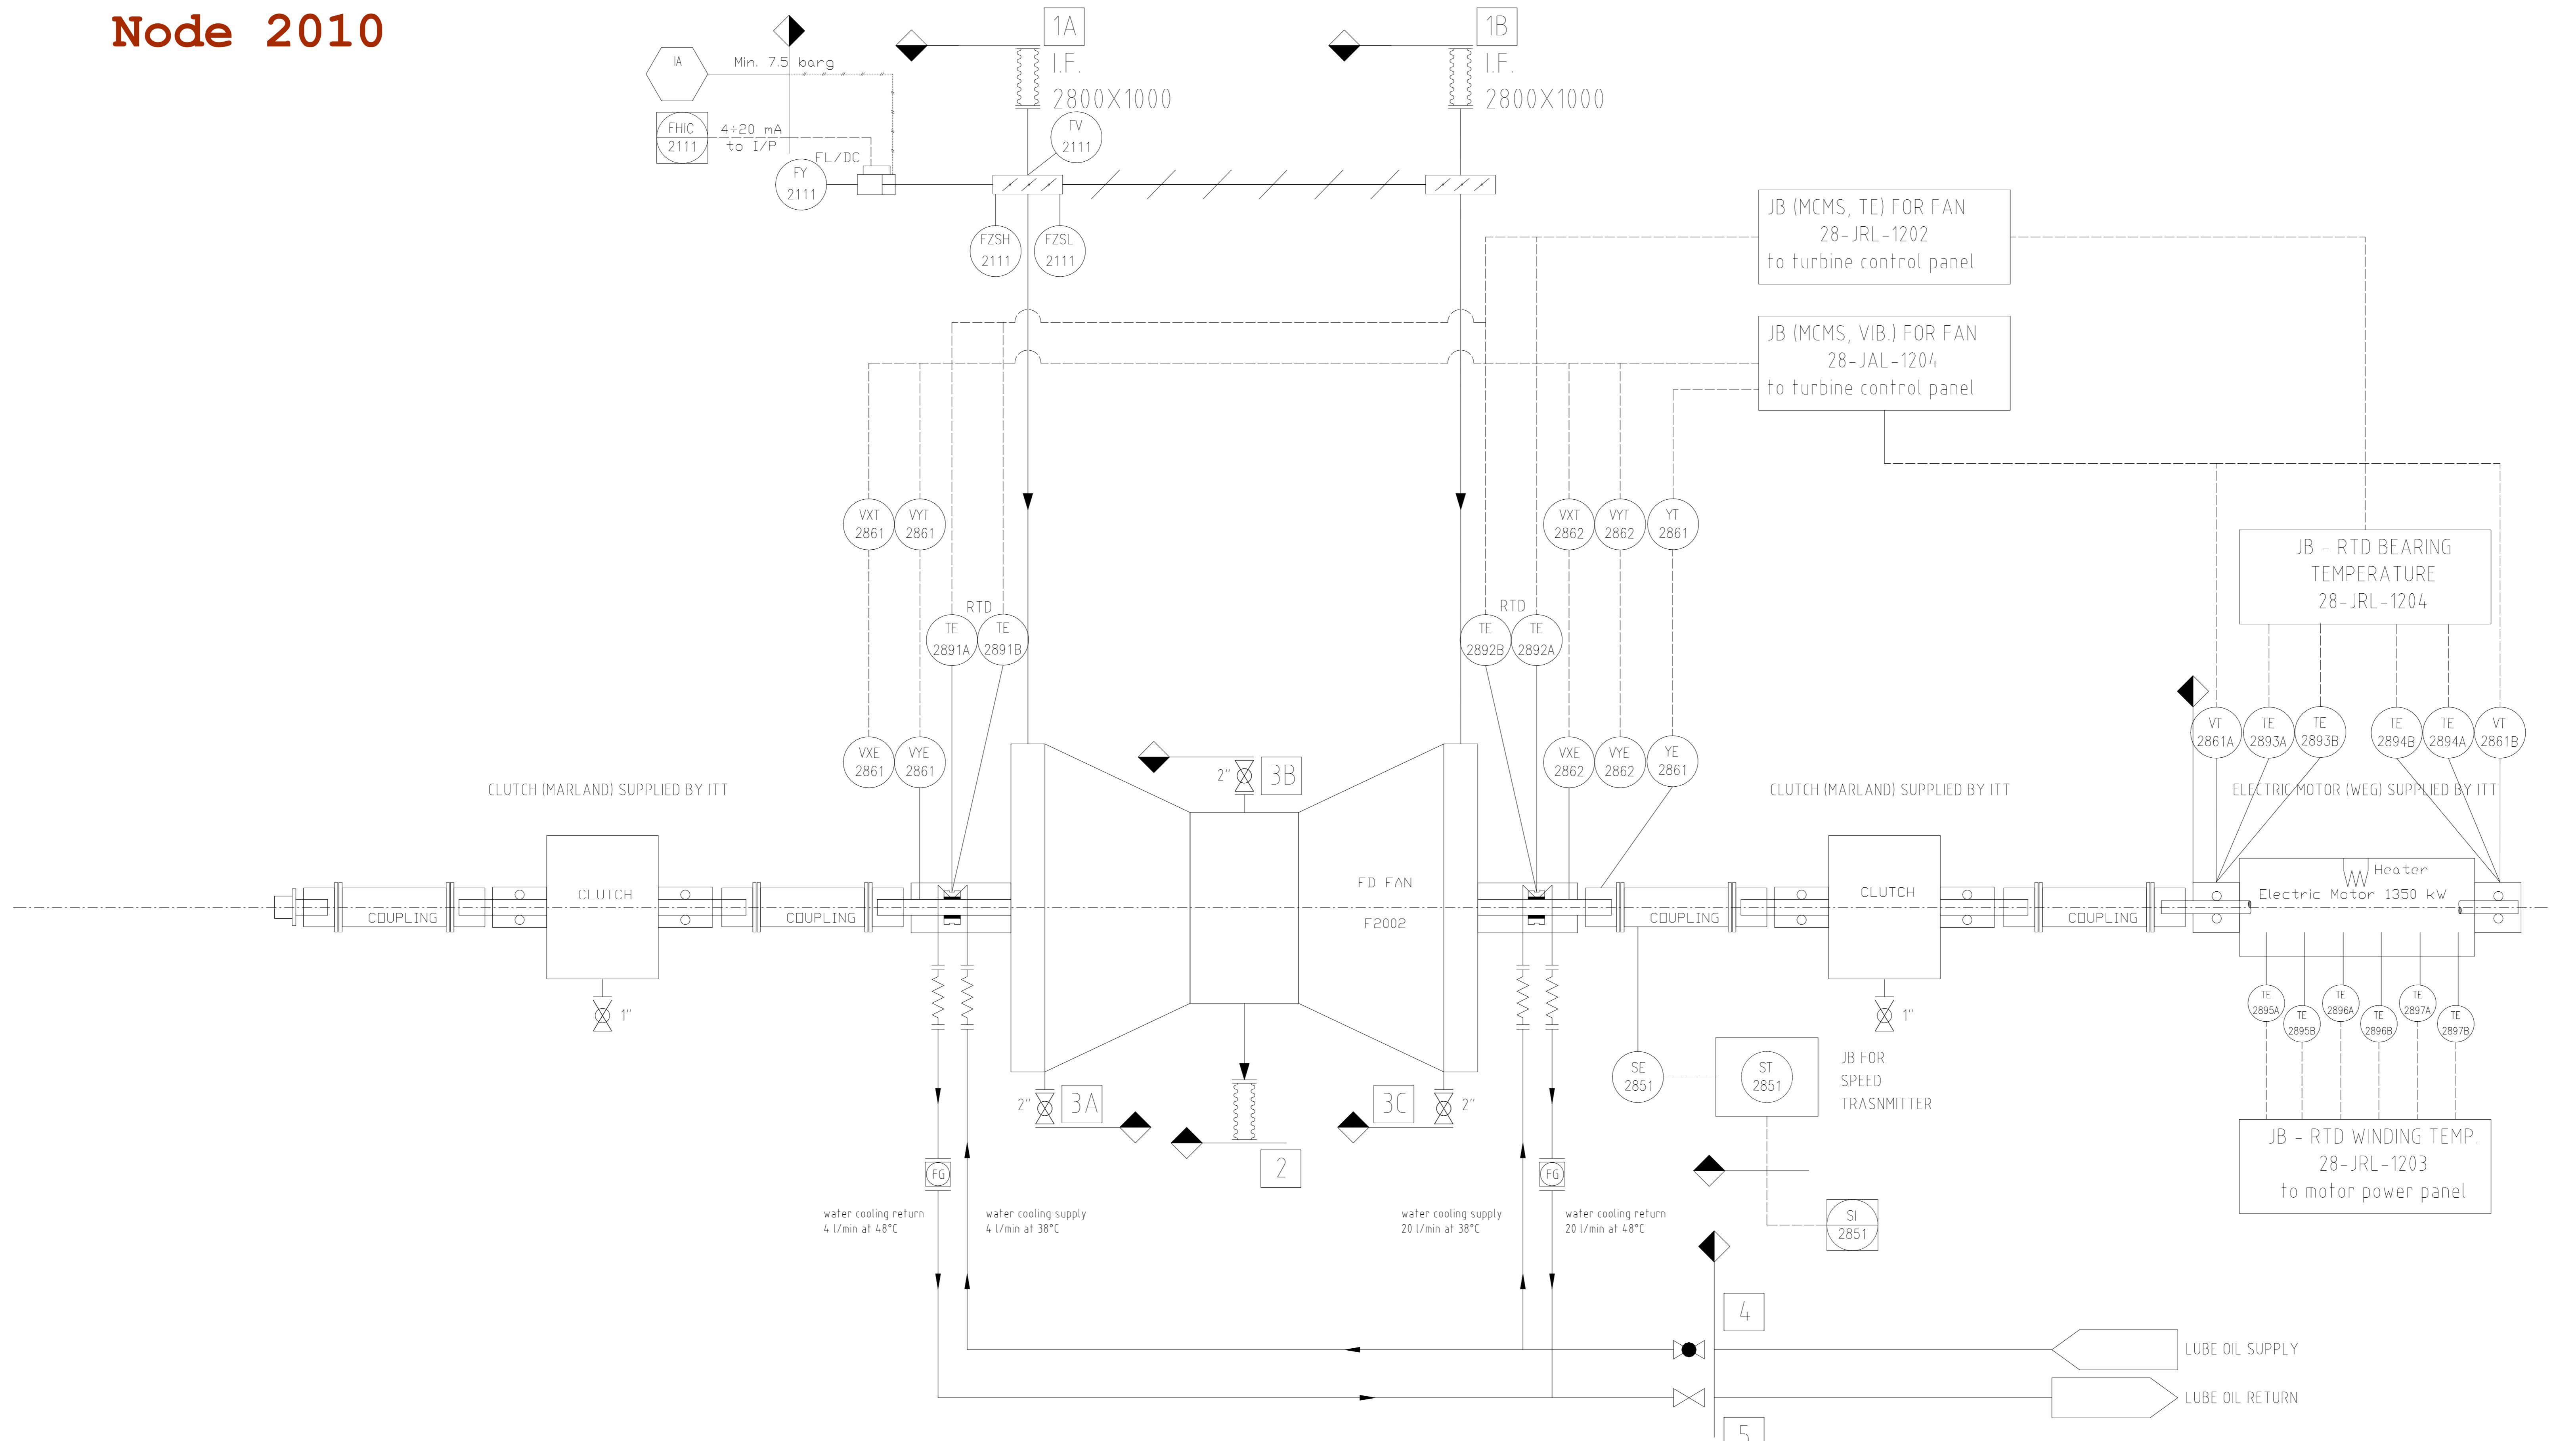
Node 2010

LEGENDA	
MECHANICAL LINK	WATER COOLING LINE
WATER COOLING LINE	Flexible pipe for adjustments
PNEUMATIC SIGNAL LINE	FLOW GLASS
OIL PIPING	FIELD INSTRUMENT
STEAM PIPING	MAIN CONTROL ROOM INSTRUMENT
INSTRUMENT CAPILLARY TUBING	REMOTE/LOCAL PANEL - MOUNTED INSTRUMENT
SOFTWARE LINK	DCS BY CUSTOMER
ELECTRICAL SIGNAL LEAD	INTERLOCK IN CUSTOMER ESD
BALL VALVE	
GLOBE VALVE	
GATE VALVE	
CHECK VALVE	
SAFETY VALVE	
A) ALL OIL PIPING STAINLESS STEEL AISI 316L SCH 40	
B) ALL TUBING AND FITTINGS STAINLESS STEEL AISI 317L

SE = SPEED PROBE
 VXE = VIBRATION SENSOR AXIS X
 VYE = VIBRATION SENSOR AXIS Y
 YE = KEY PHASOR SENSOR
 VT = VELOMOTOR SENSOR
