TIANCHEN CORP. CHINA	Project :	MKP Methanol Project			Owner :

شرکت کیمیای پارس خاورمیانه Middle East Kumiya Pars Co.
	Unit	General Technical	Phase	Detail Engineering	
	Doc. Title :	PACKAGE HAZOP			
Vendor :

PACKAGE HAZOP

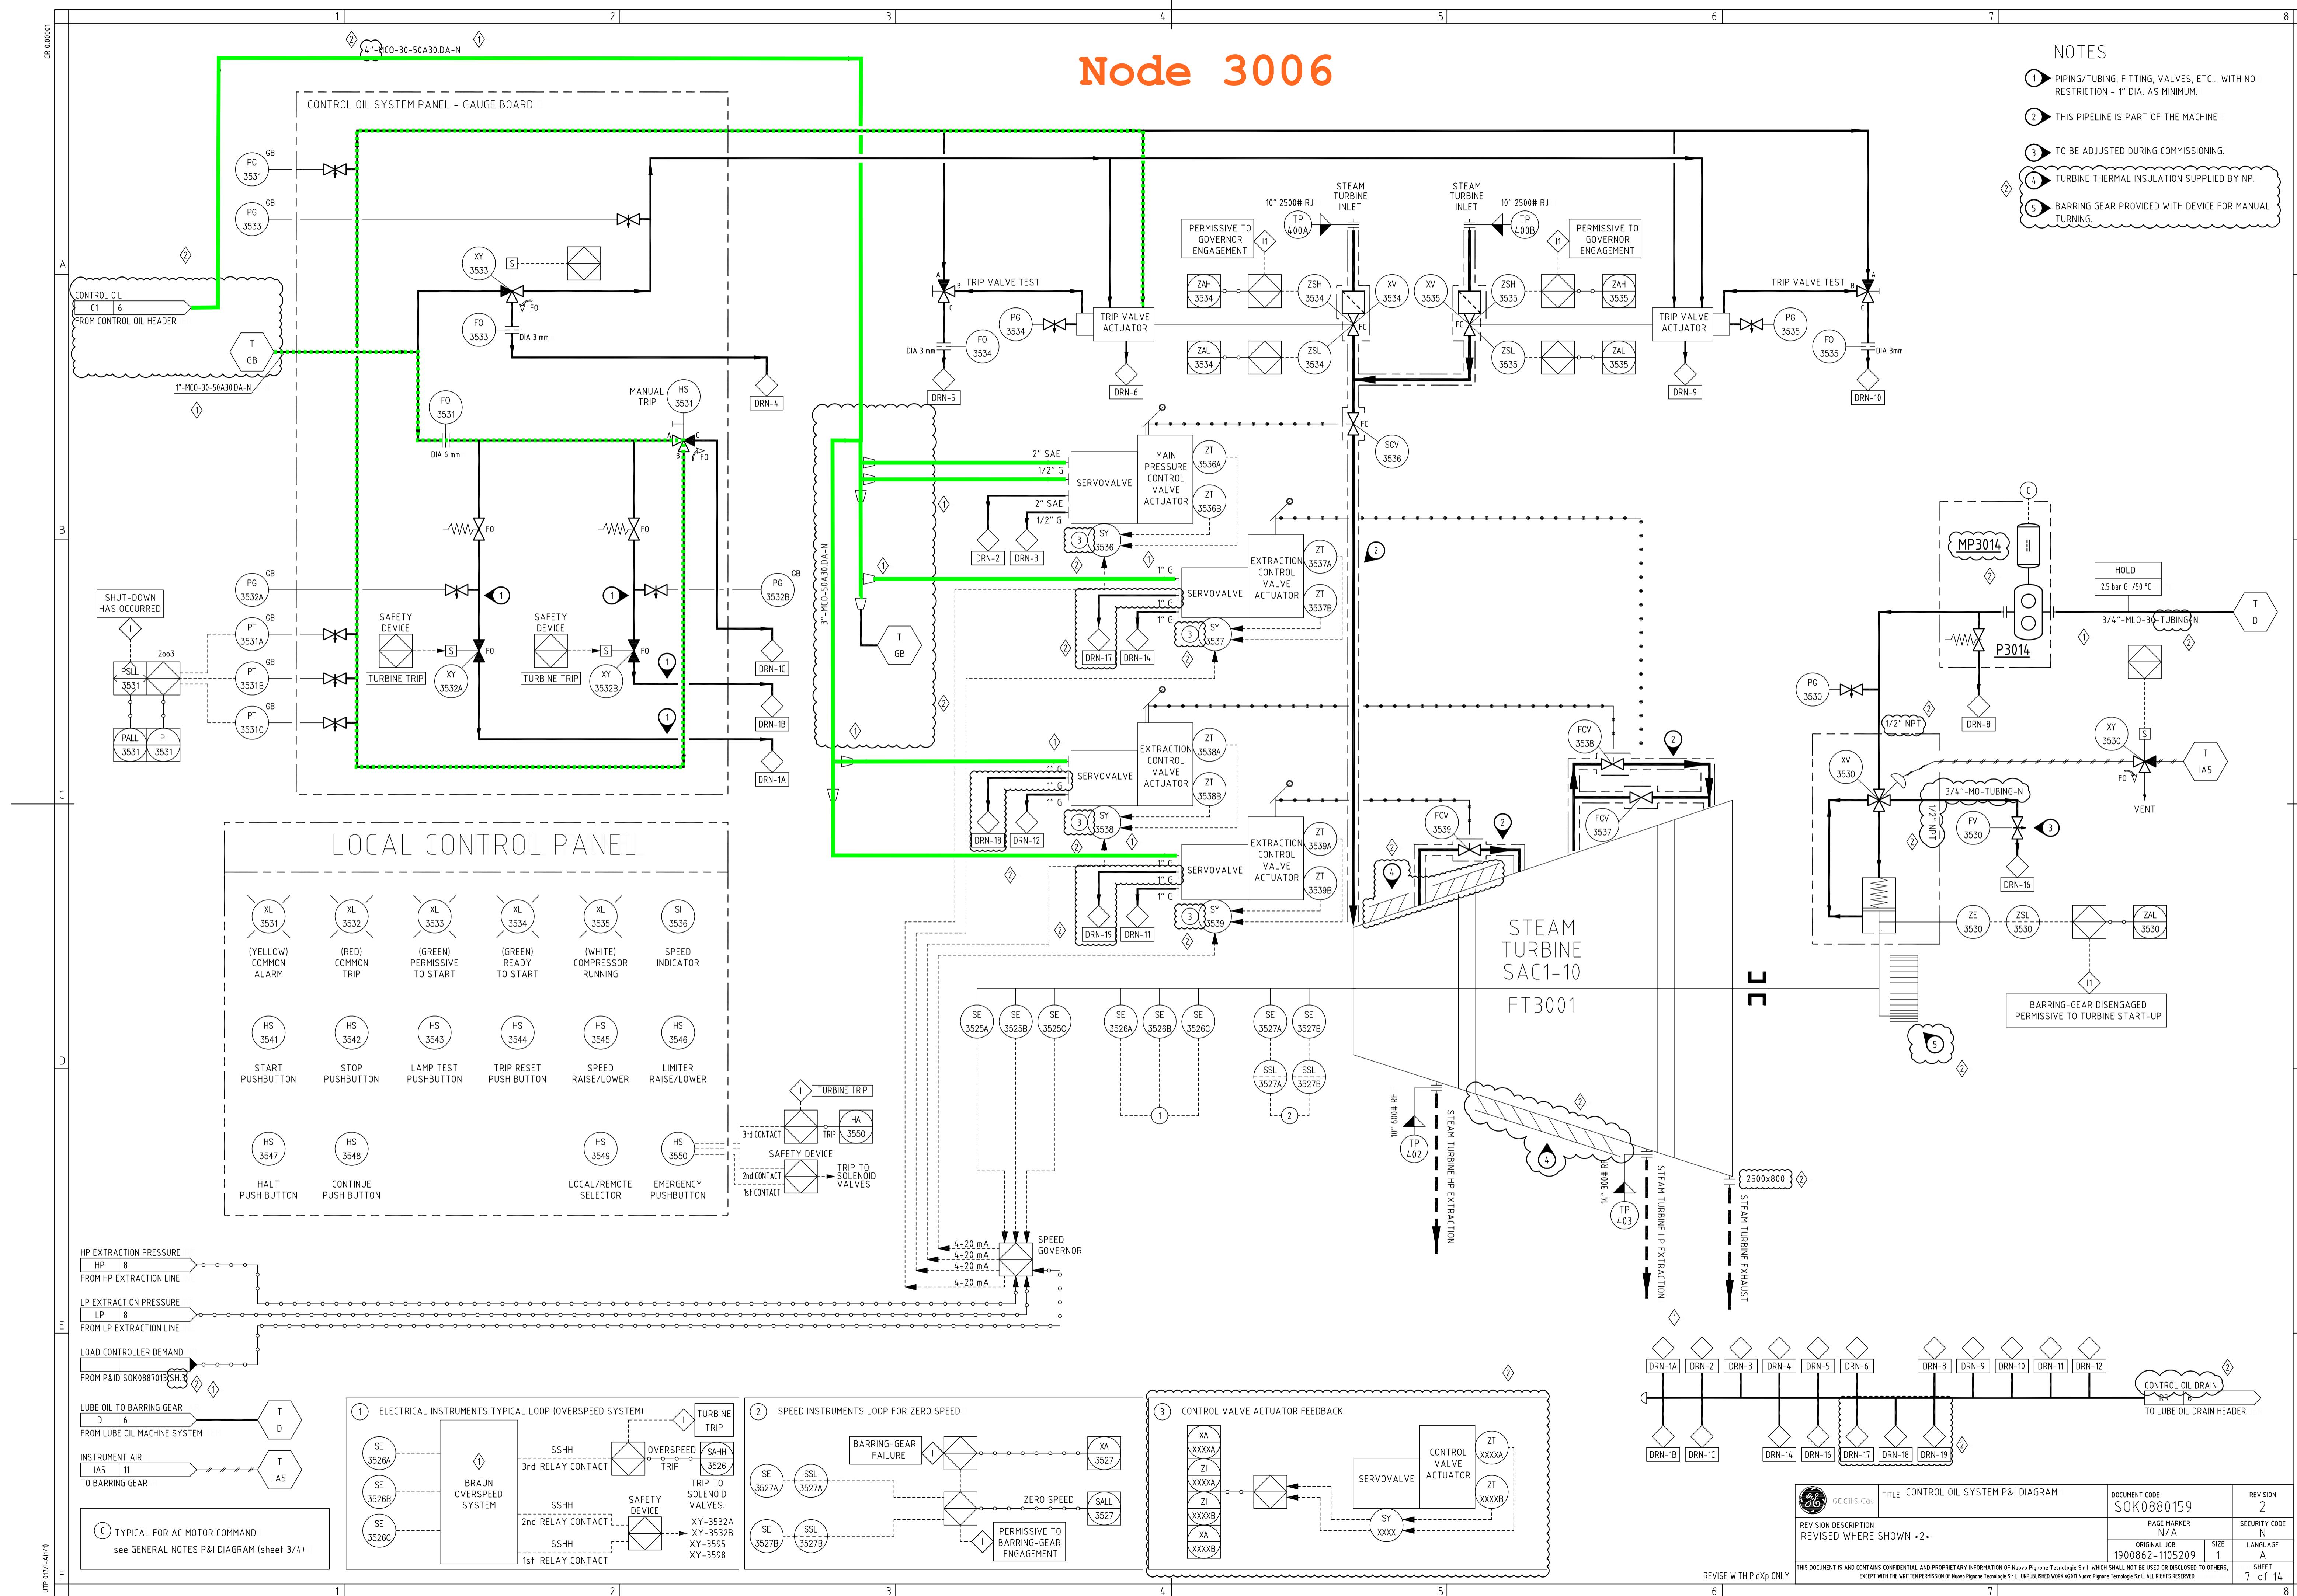
- (1) PIPING/TUBING, FITTING, VALVES, ETC... WITH NO RESTRICTION - 1" DIA. AS MINIMUM.
- (2) THIS PIPELINE IS PART OF THE MACHINE.
- (3) TO BE ADJUSTED DURING COMMISSIONING.
- (4) TURBINE THERMAL INSULATION SUPPLIED BY NP.
- (5) BARRING GEAR PROVIDED WITH DEVICE FOR MANUAL TURNING

GE Oil & Gas		TITLE CONTROL OIL SYSTEM P&I DIAGRAM		DOCUMENT CODE SOK0880159		REVISION 2	
REVISION DESCRIPTION REVISED WHERE SHOWN ~2~		PAGE MARKER N/A		SECURITY CODE N		ORIGINAL 08 1900862-1105209	
SIZE 1		LANGUAGE A		SHEET 1		7 of 14	
THIS DOCUMENT IS AND CONTAINS CONFIDENTIAL AND PROPRIETARY INFORMATION OF Nuovo Pignone Tecnologie S.r.l. WHICH SHALL NOT BE DISCLOSED TO OTHERS, EXCEPT WITH THE WRITTEN PERMISSION OF Nuovo Pignone Tecnologie S.r.l. UNPUBLISHED WORK ©2011 Nuovo Pignone Tecnologie S.r.l. ALL RIGHTS RESERVED							
REVISE WITH PidXp ONLY

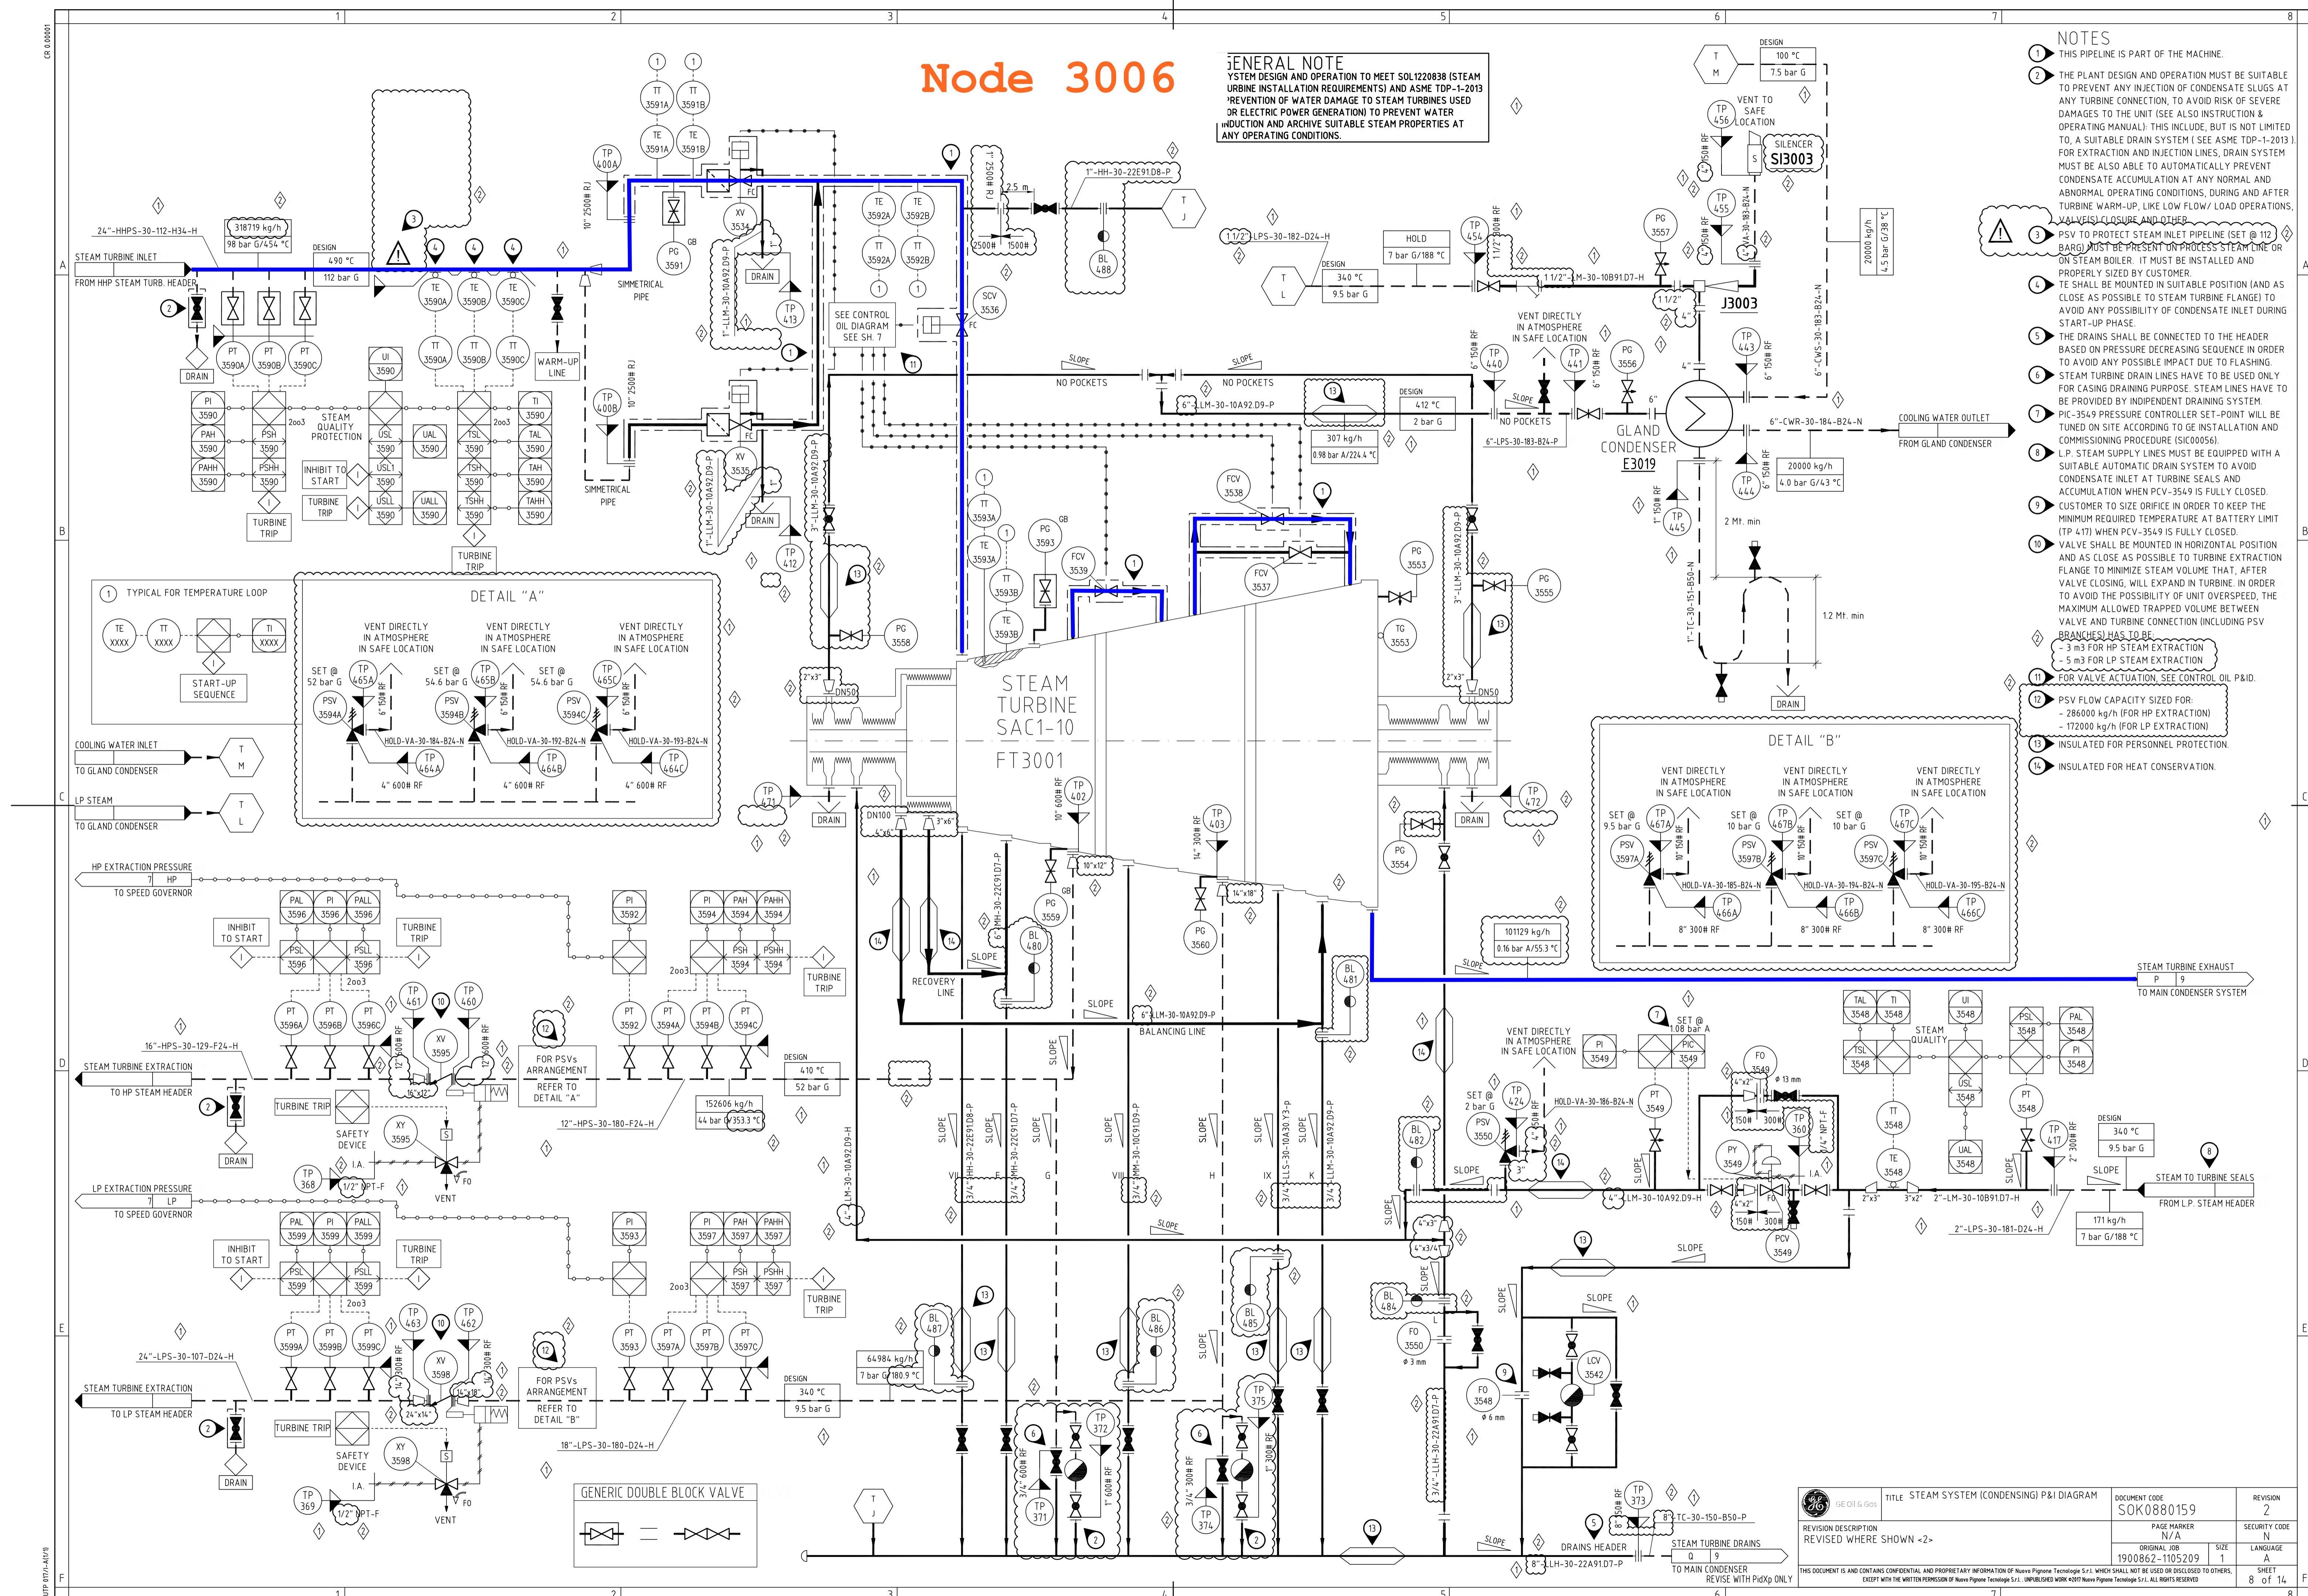
- 3 m³ FOR HP STEAM EXTRACTION
- 5 m³ FOR LP STEAM EXTRACTION
- (11) FOR VALVE ACTUATION, SEE CONTROL OIL P&ID.
- (12) PSV FLOW CAPACITY SIZED FOR:
- 286000 kg/h (FOR HP EXTRACTION)

- 172000 kg/h (FOR LP EXTRACTION)
- (13) INSULATED FOR PERSONNEL PROTECTION.
- (14) INSULATED FOR HEAT CONSERVATION.

GE Oil & Gas		TITLE STEAM SYSTEM (CONDENSING) P&I DIAGRAM		DOCUMENT CODE SOK0880159		REVISION 2	
REVISION DESCRIPTION REVISED WHERE SHOWN ~2~		PAGE MARKER N/A		SECURITY CODE N		SIZE 1	
ORIGINAL 06 1900862-1105209		LANGUAGE A		SHEET 8 of 14			
THIS DOCUMENT IS AND CONTAINS CONFIDENTIAL AND PROPRIETARY INFORMATION OF Nuovo Pignone Tecnologie S.r.l. WHICH SHALL NOT BE USED OR DISCLOSED TO OTHERS, EXCEPT WITH THE WRITTEN PERMISSION OF Nuovo Pignone Tecnologie S.r.l. UNPUBLISHED WORK ©2019 Nuovo Pignone Tecnologie S.r.l. ALL RIGHTS RESERVED

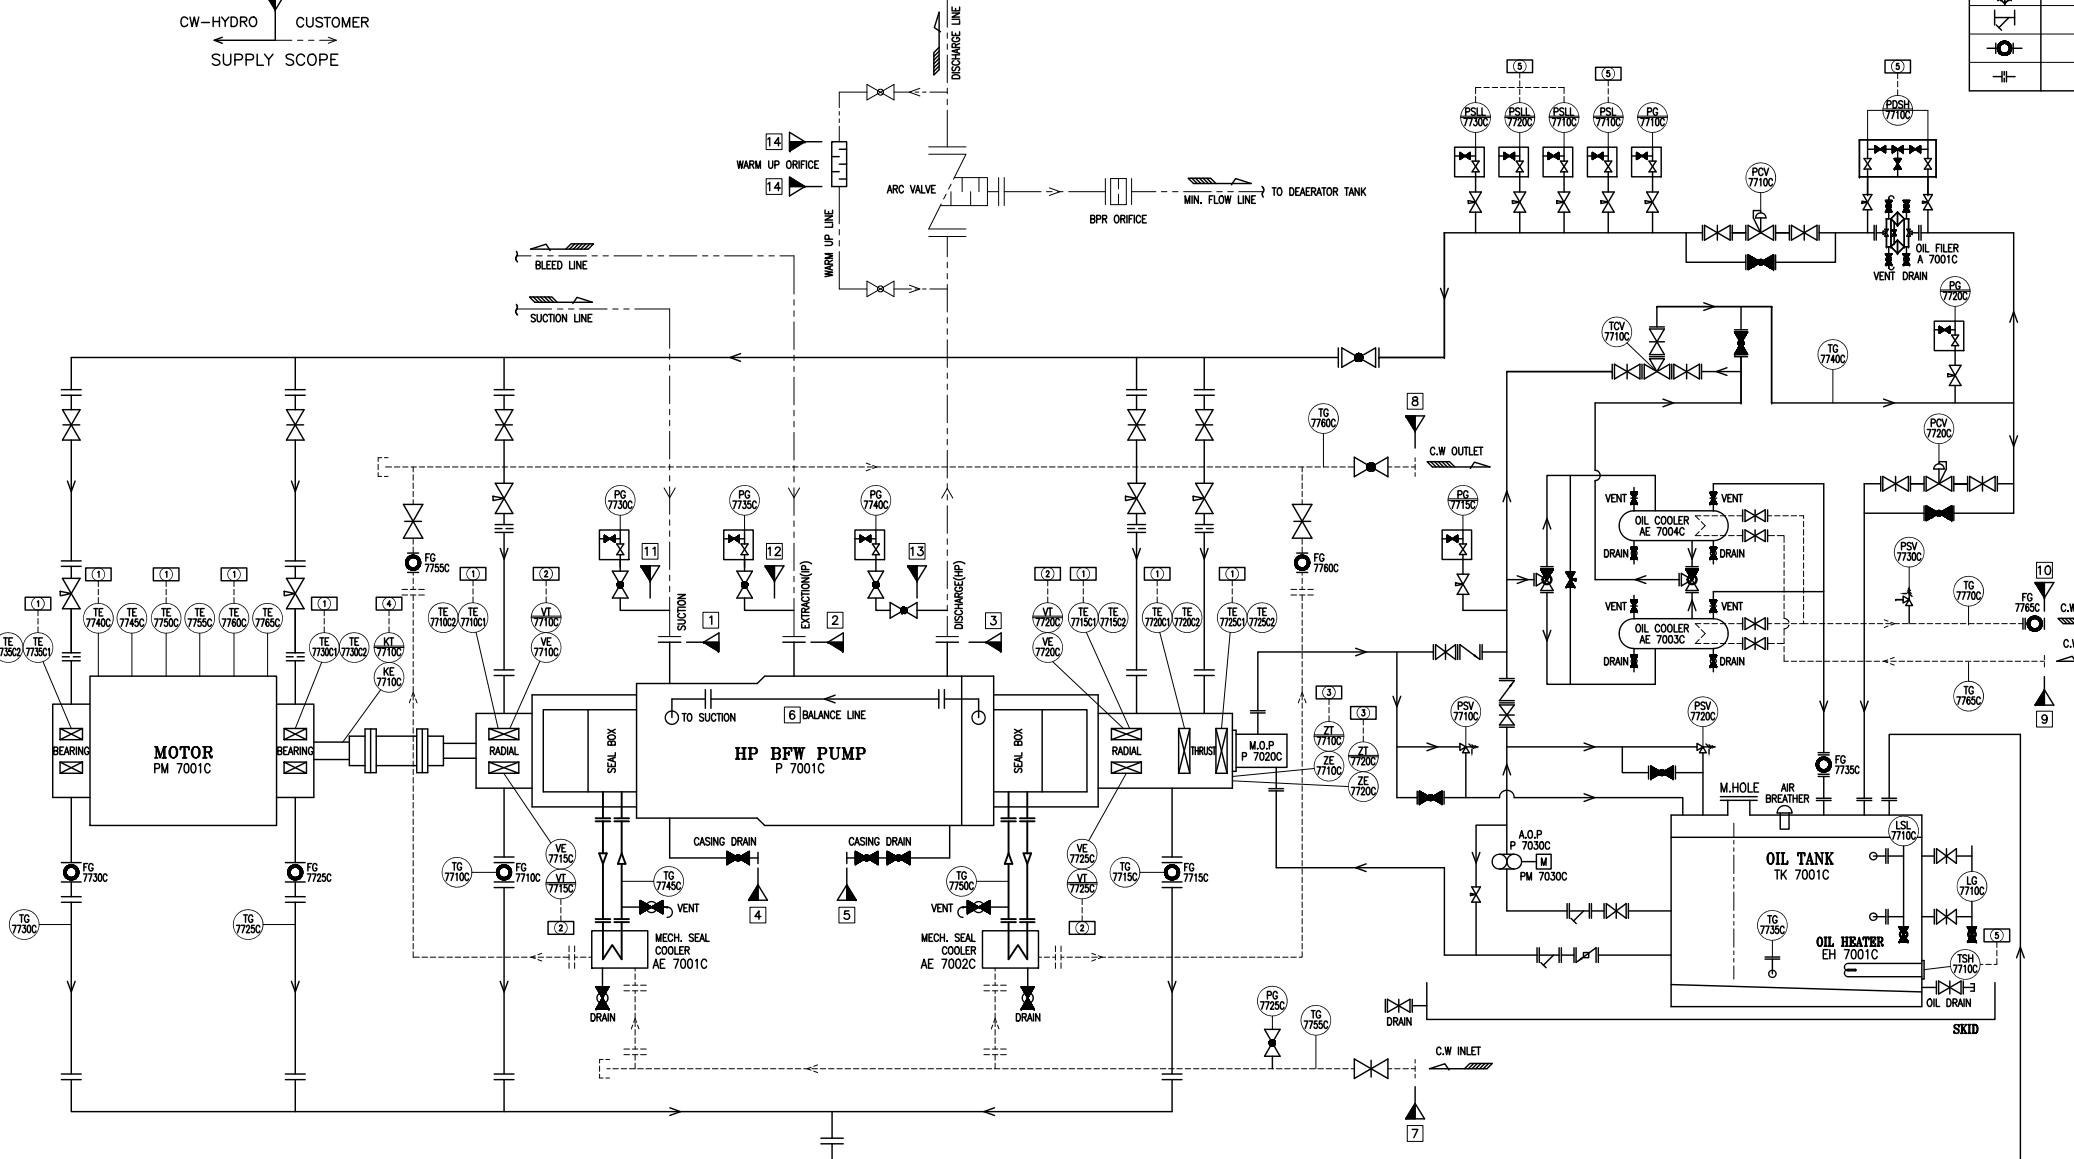
TERMINAL POINTS

NO.	DESCRIPTION	RATING & SIZE
1	PUMP SUCTION	DN200 ASME 150LB RF
2	PUMP EXTRACTION	DN50 ASME 600LB WN RF
3	PUMP DISCHARGE	DN150 ASME 1500LB RJT
4	CASING DRAIN(SUCTION SIDE)	DN25 ASME 300LB SW RF
5	CASING DRAIN(DISCHARGE SIDE)	DN25 ASME 1500LB SW RF
6	BALANCE LINE	DN40 ASME 300LB SW RF
7	C.W. INLET FOR M/S COOLER	DN40 ASME 150LB SW RF
8	C.W. OUTLET FOR M/S COOLER	DN40 ASME 150LB SW RF
9	C.W. INLET FOR LUBE. OIL COOLER	DN40 ASME 150LB SW RF
10	C.W. OUTLET FOR LUBE. OIL COOLER	DN40 ASME 150LB SW RF
11	SUCTION PRESSURE GAUGE	DN15 600LB SW
12	EXTRACTION PRESSURE GAUGE	DN15 600LB SW
13	DISCHARGE PRESSURE GAUGE	DN15 1500LB SW
14	WARM UP LINE ORIFICE	DN20 ASME 1500LB SW RF

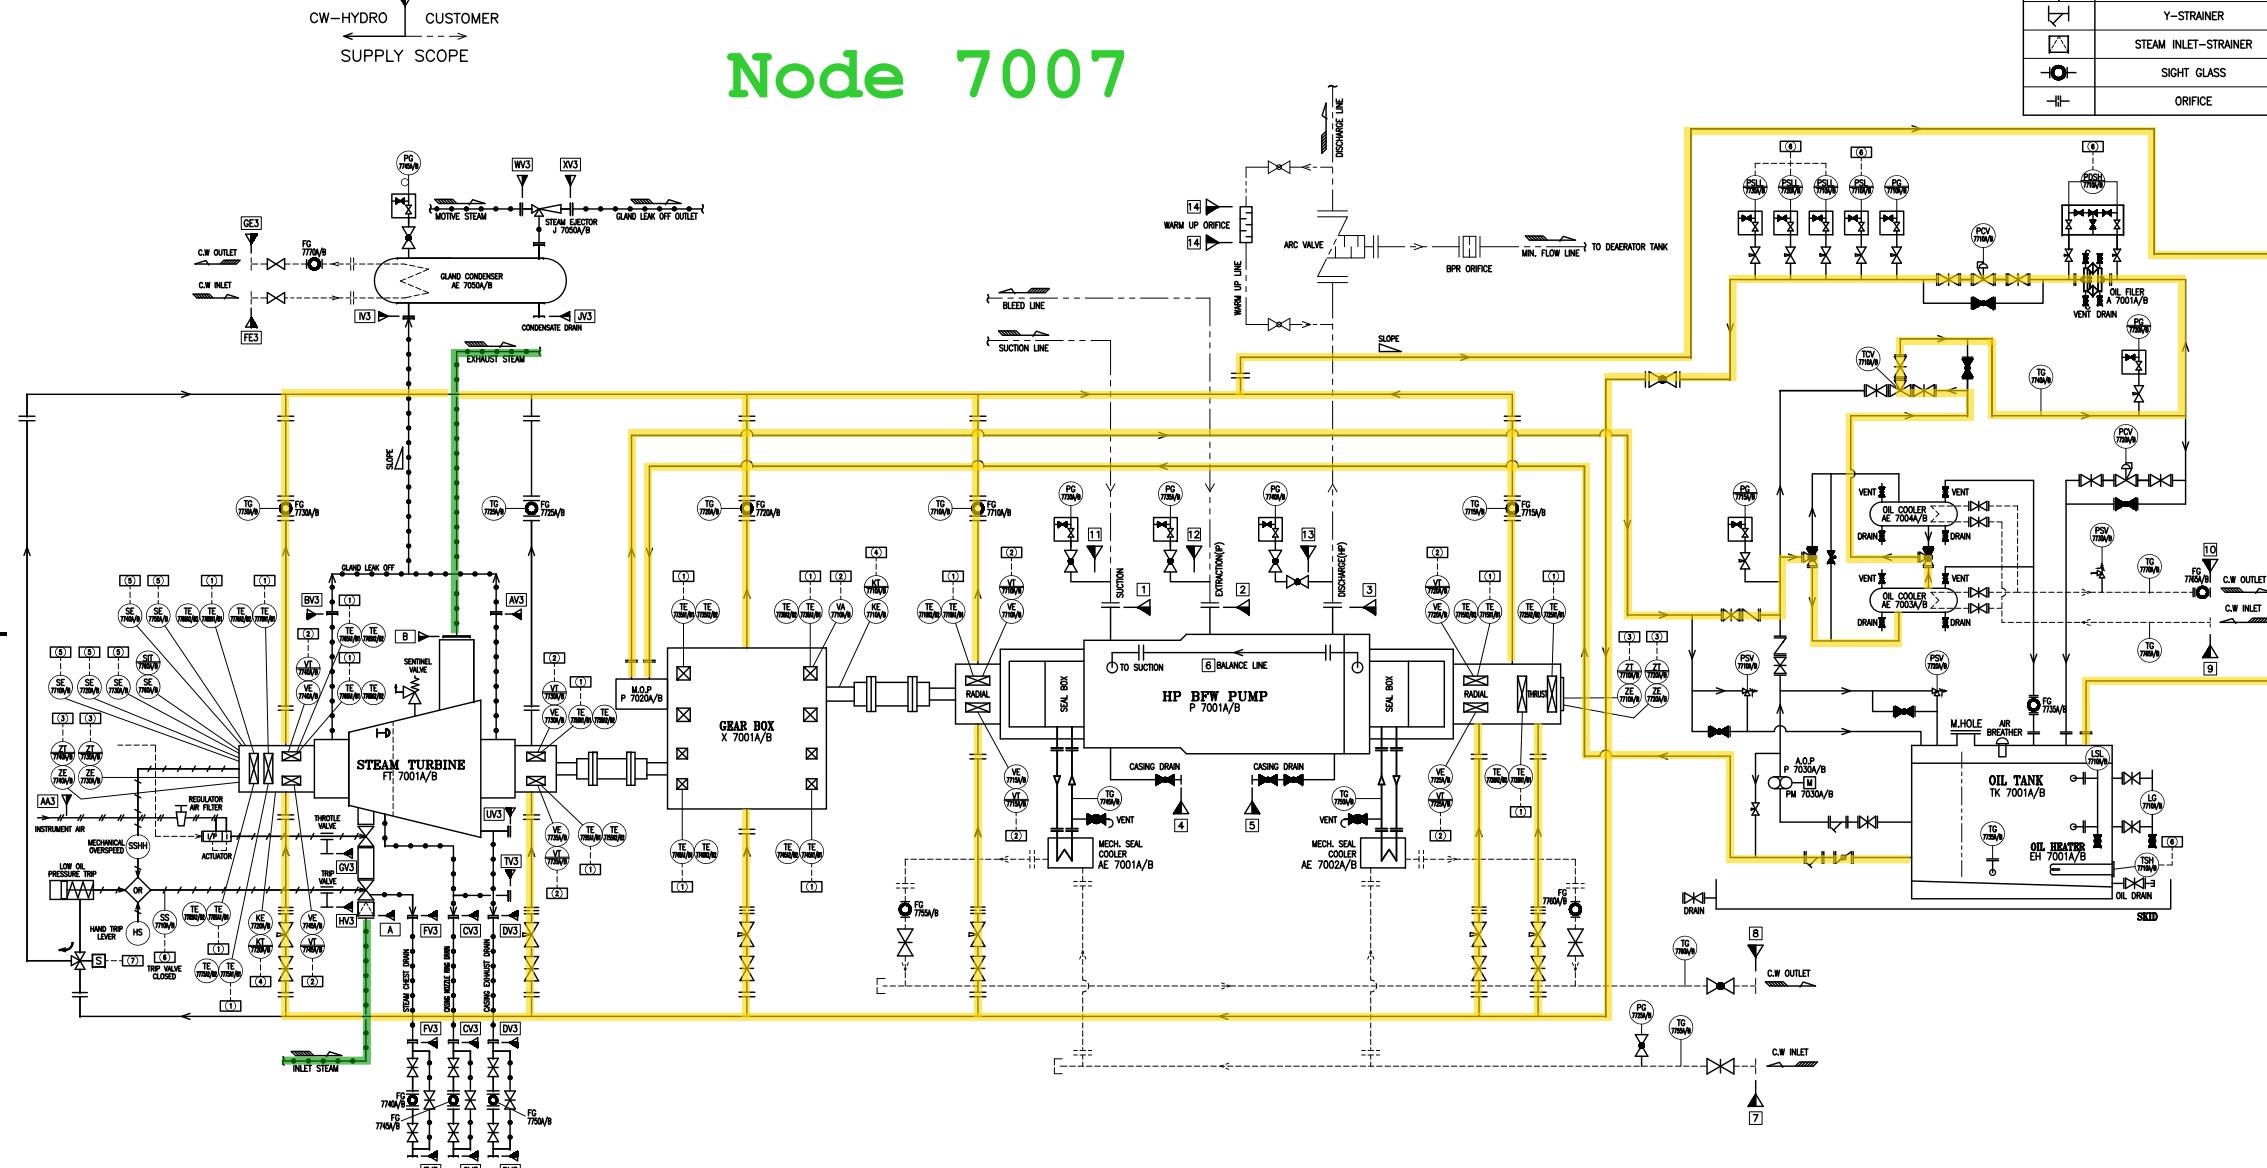
Node 7007

TERMINAL POINTS for TURBINE

NO.	DESCRIPTION	RATING & SIZE
A	STEAM TURBINE INLET	DN150 ASME 600LB RF
B	STEAM TURBINE EXHAUST	DN300 ASME 150LB RF
AV3	PACKING CASE LEAK OFF	LATER
BV3	PACKING CASE LEAK OFF	LATER
CV3	STEAM TURBINE CASE NOZZLE RING DRAIN	DN20 ASME 600LB RF
DV3	STEAM TURBINE CASING EXHAUST	DN20 ASME 150LB RF
FV3	STEAM CHEST DRAIN	DN20 ASME 600LB RF
GV3	STEAM CHEST COVER LEAK OFF - GOVERNOR V/V	DN15 ASME 150LB SW RF
HV3	STEAM CHEST COVER LEAK OFF - TRIP V/V	DN20 ASME 150LB SW RF
IW3	GLAND CONDENSER - STEAM INLET	LATER
JV3	GLAND CONDENSER - CONDENSATE OUTLET	LATER
TV3	PROVISION FOR 1ST STAGE PRESS. MEASUREMENT	DN20 ASME 600LB RF
UV3	PROVISION FOR EXHAUST PRESS. MEASUREMENT	DN20 ASME 150LB RF
XV3	STEAM EJECTOR - OUTLET	LATER
WV3	STEAM EJECTOR - INLET MOTIVE STEAM	LATER
FE3	C.W. INLET FOR STEAM GLAND	LATER
GE3	C.W. OUTLET FOR STEAM GLAND	LATER
AA3	ACTUATOR AIR INLET	1/4" NPT F

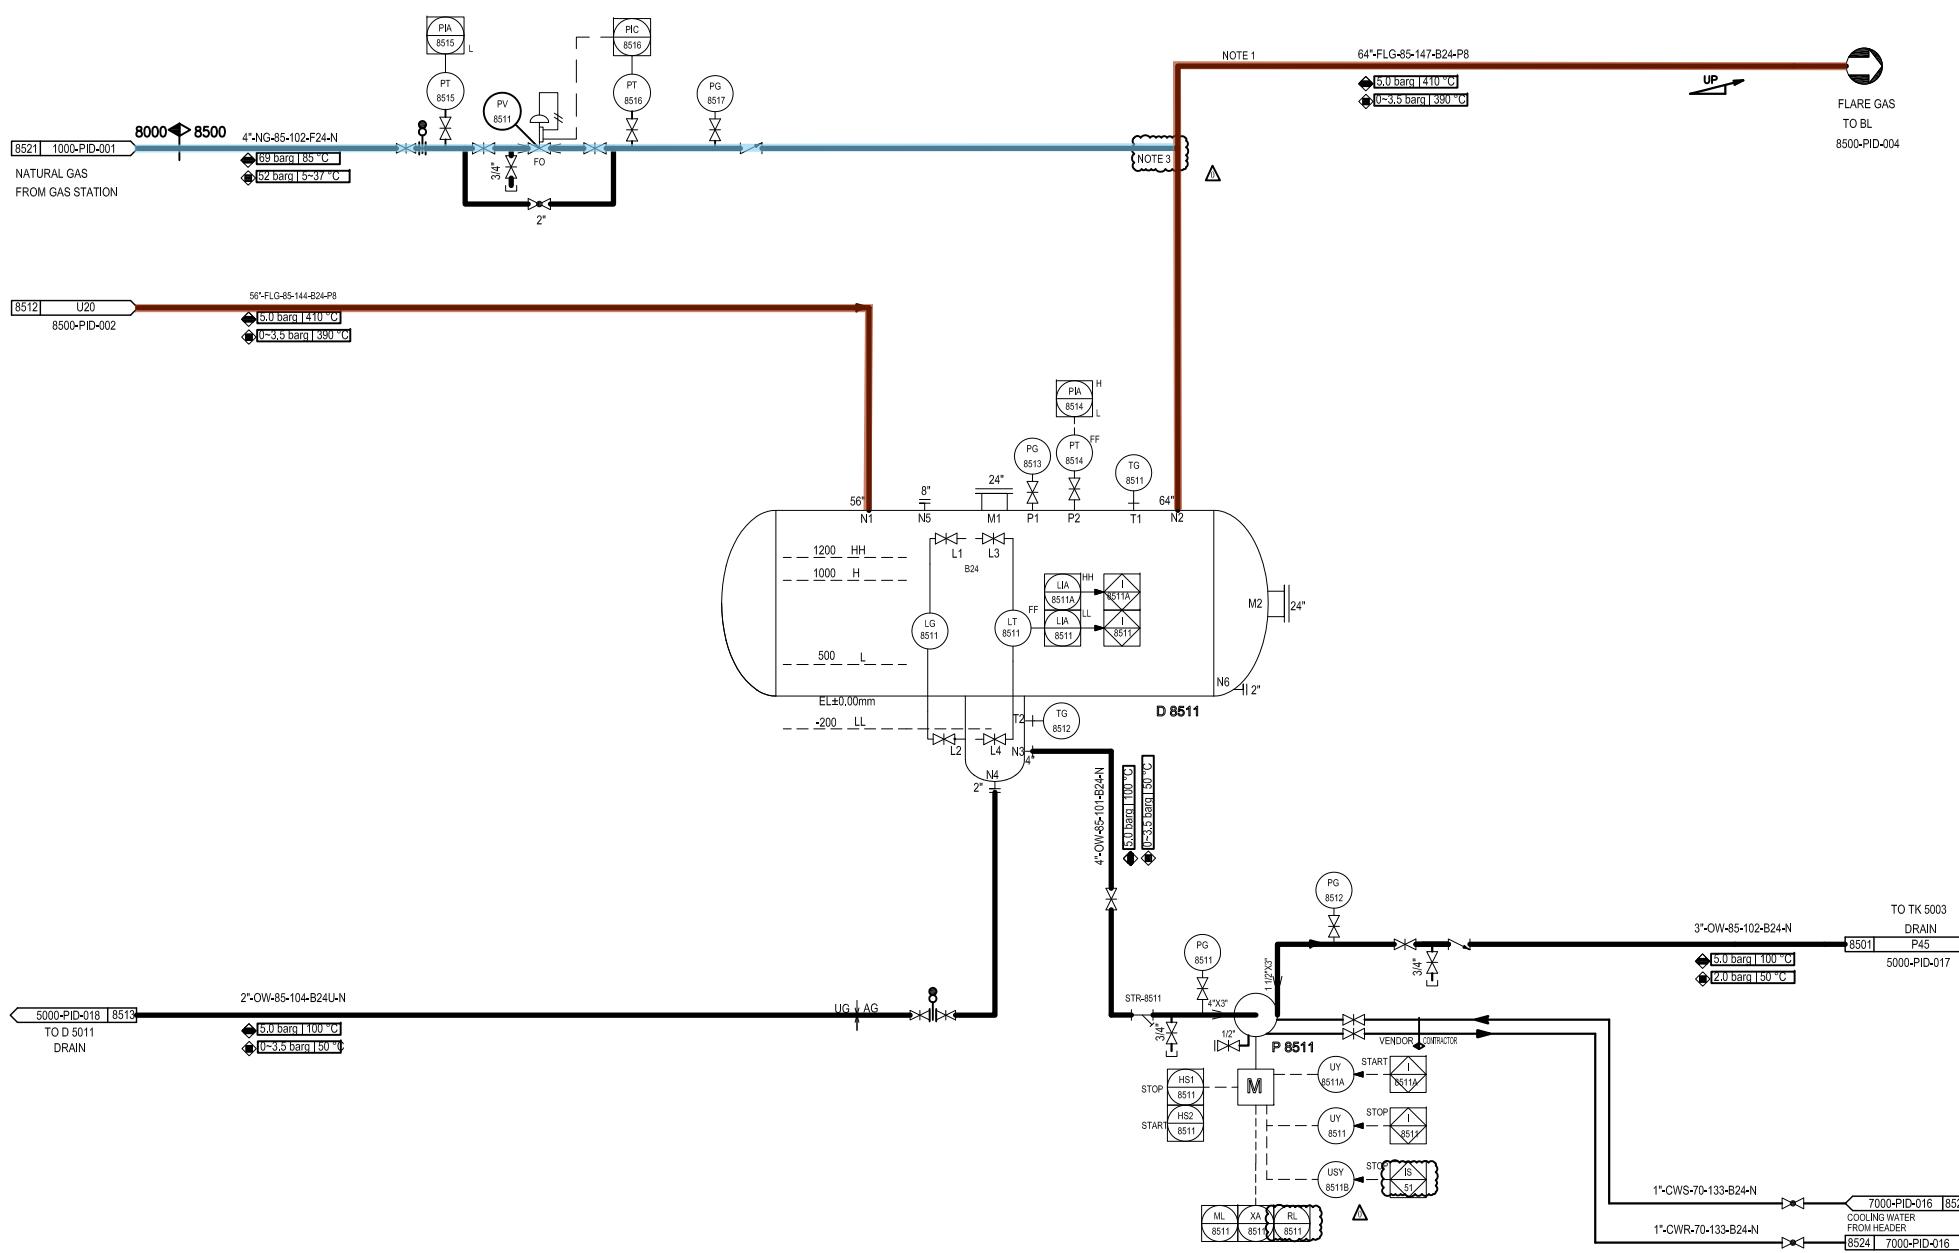
Node 7009

- + GENERAL NOTE:
 - 1) LOW POINT DRAINS AND HIGH POINT VENT MUST BE ADDED.
 - 2) FLARE LINE WITH AN UPWARD SLOPE SHALL ADD LOW POINT DRAINS.
- + NOTE:
 - 1) THE DIRECT ROUTING DISTANCE BETWEEN THE TIE-IN POINT LOCATION OF THE METHANOL PLANT AND THE ACTUAL FLARE SITE IS ABOUT 1600 M.
 - 2) FOR THE FLARE PIPING ROUTING, ONE STRESS EXPANSION LOOP IS SET AT ABOUT EVERY 60M DISTANCE.
 - 3) THIS CONNECTION POINT IS NEAR TO K.O.D INSIDE OF PLANT B.L.

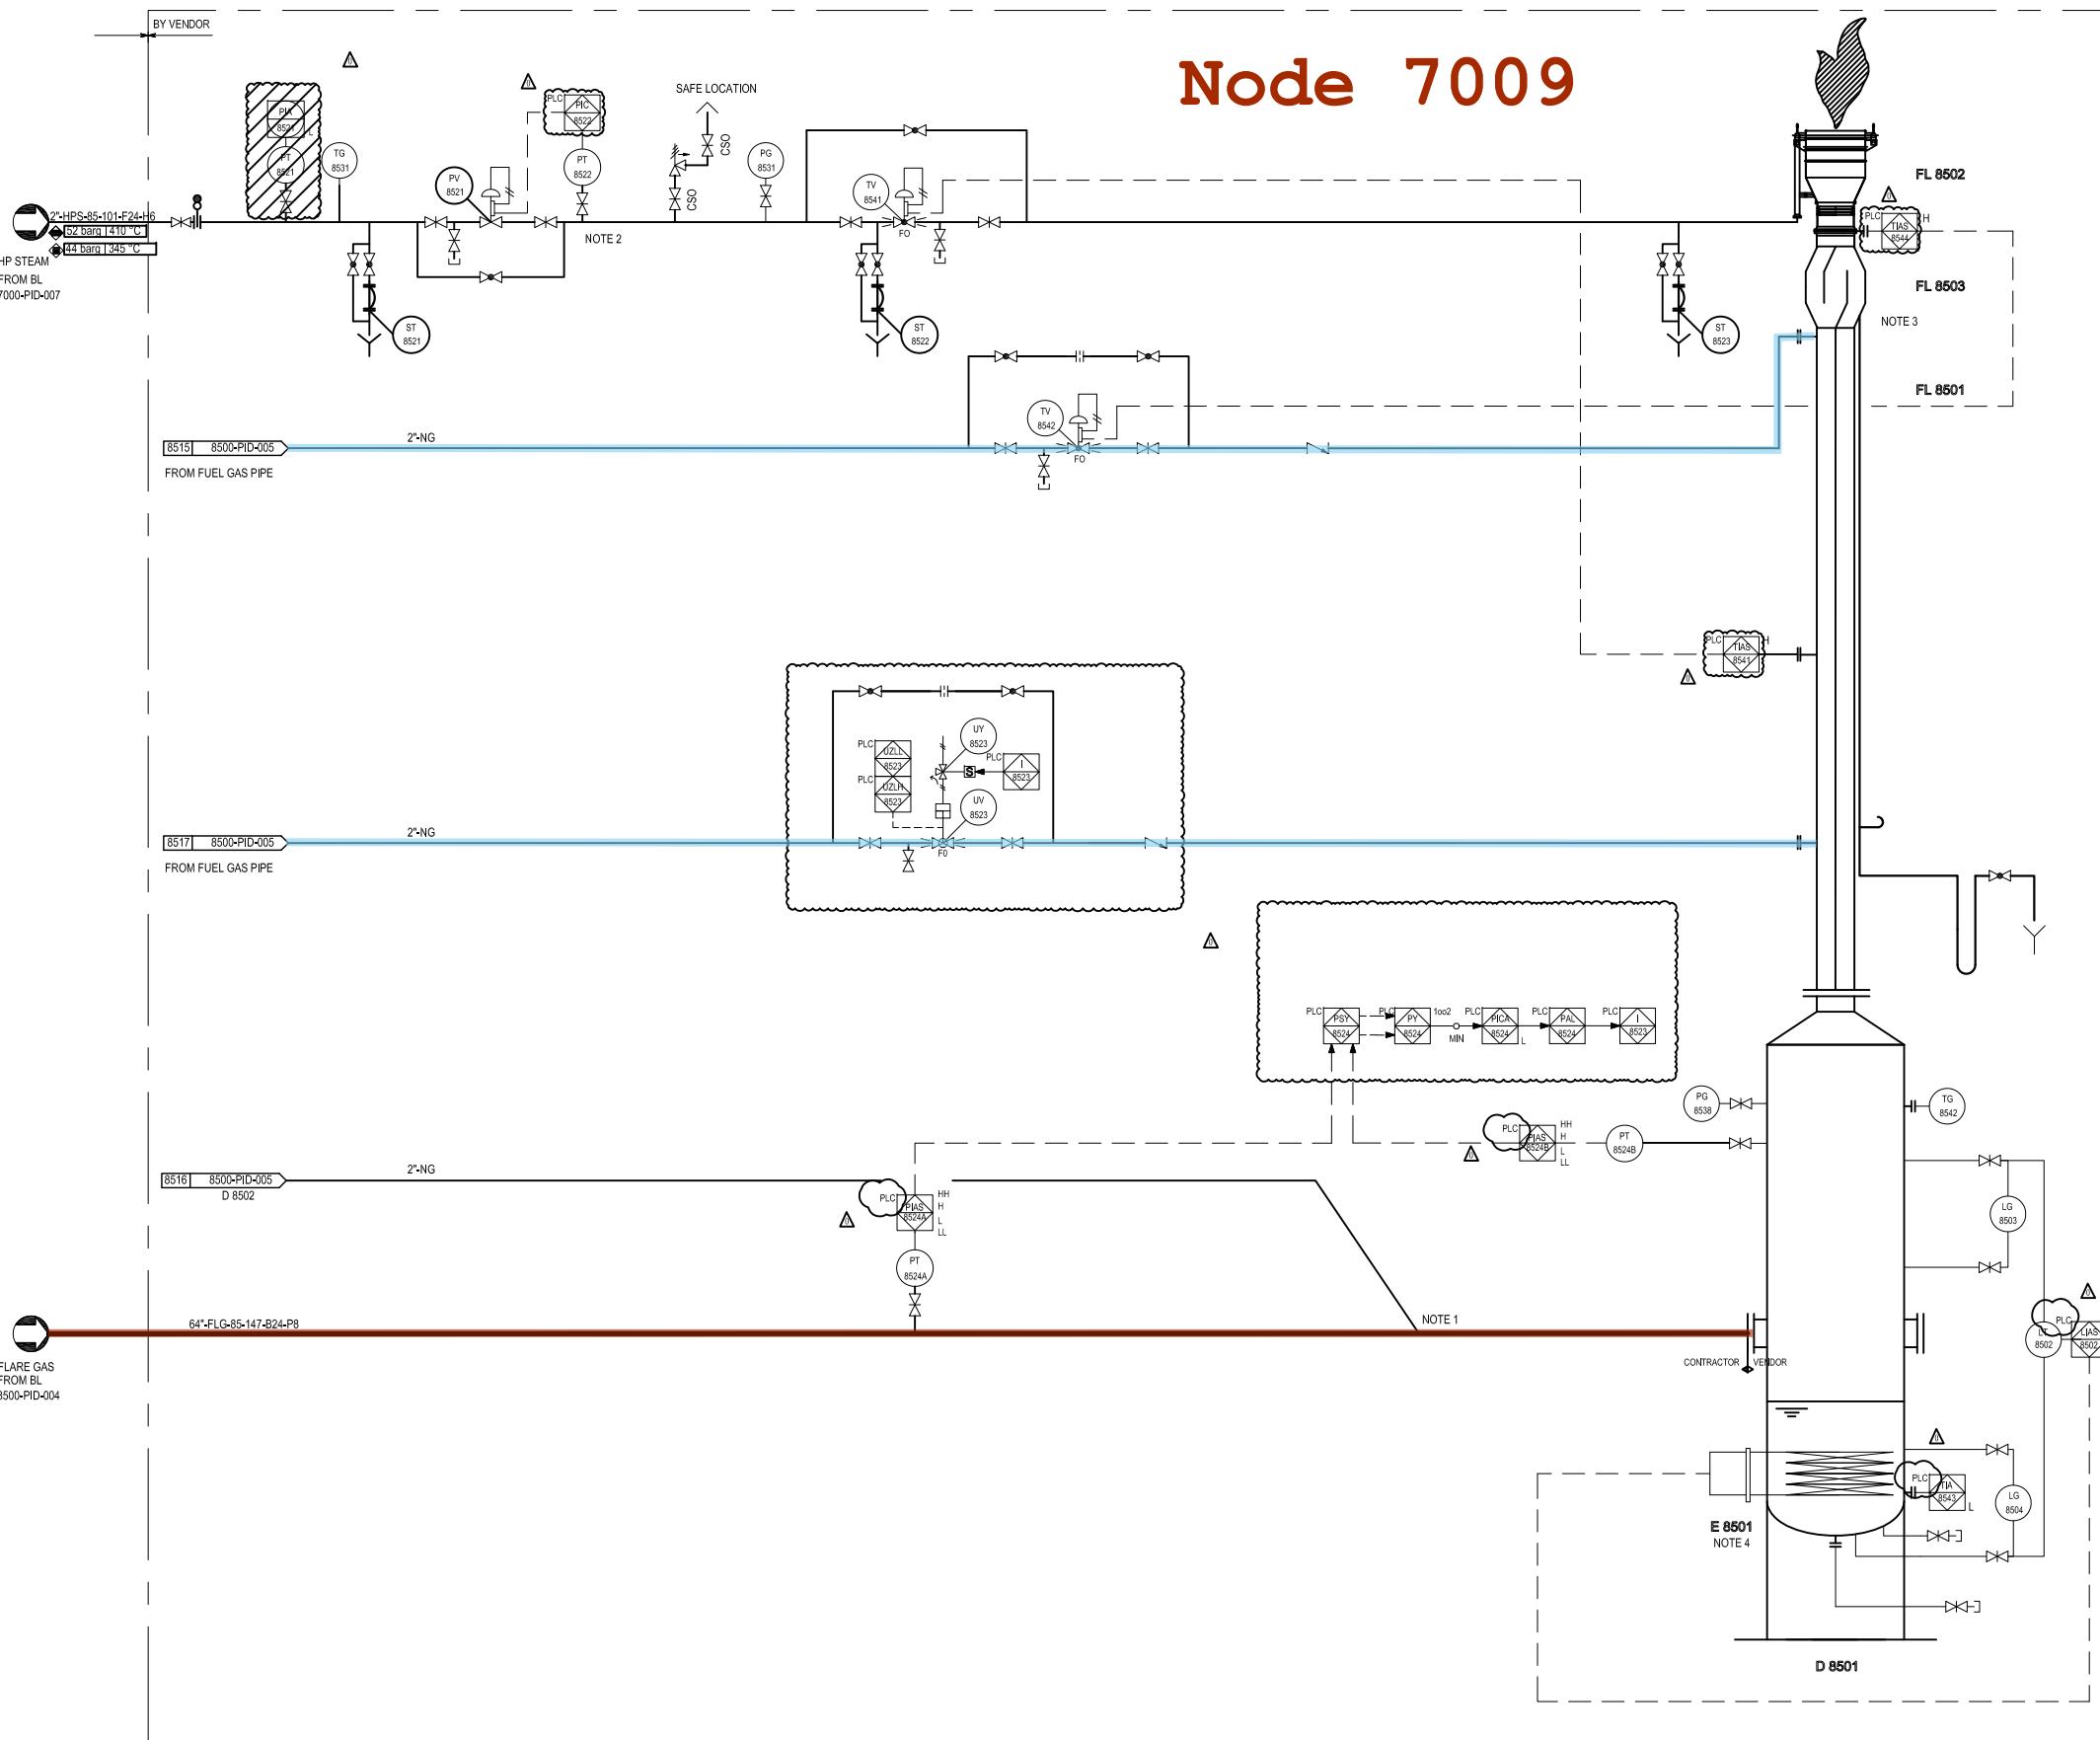
Node 7009

1	2	3	4	5	6	7	8	9	10	11	12
A	D 8501 Knock-Out Drum ID x LENGTH(T-T) DESIGN PRESS. DESIGN TEMP. INSULATION CLADDING/LINING	2 HOLD mm 7.0 barg 410 °C YES NONE	FL 8501 Flare Stack ID x LENGTH(T-T) DESIGN PRESS. DESIGN TEMP. INSULATION	FL 8502 Flare Tip ID x LENGTH(T-T) DESIGN PRESS. DESIGN TEMP. INSULATION	FL 8503 Molecular Seal ID x LENGTH(T-T) DESIGN PRESS. DESIGN TEMP. INSULATION	E 8501 Electric Heater Power DESIGN PRESS. DESIGN TEMP. INSULATION

+ GENERAL NOTE:
 1) LOW POINT DRAINS AND HIGH POINT VENT MUST BE ADDED DURING DETAILED ENGINEERING.
 2) FLARE LINE WITH AN UPWARD SLOPE SHALL ADD LOW POINT DRAINS, THE DETAIL INFORMATION ABOUT IT SHOULD SPECIFY IN DE PHASE.
