TIANCHEN CORP. CHINA	Project :	MKP Methanol Project			Owner :

شرکت کیمیای پارس خاورمیانه Middle East Kumiya Pars Co.
	Unit	General Technical	Phase	Detail Engineering	
	Doc. Title :	PACKAGE HAZOP			
Vendor :

PACKAGE HAZOP

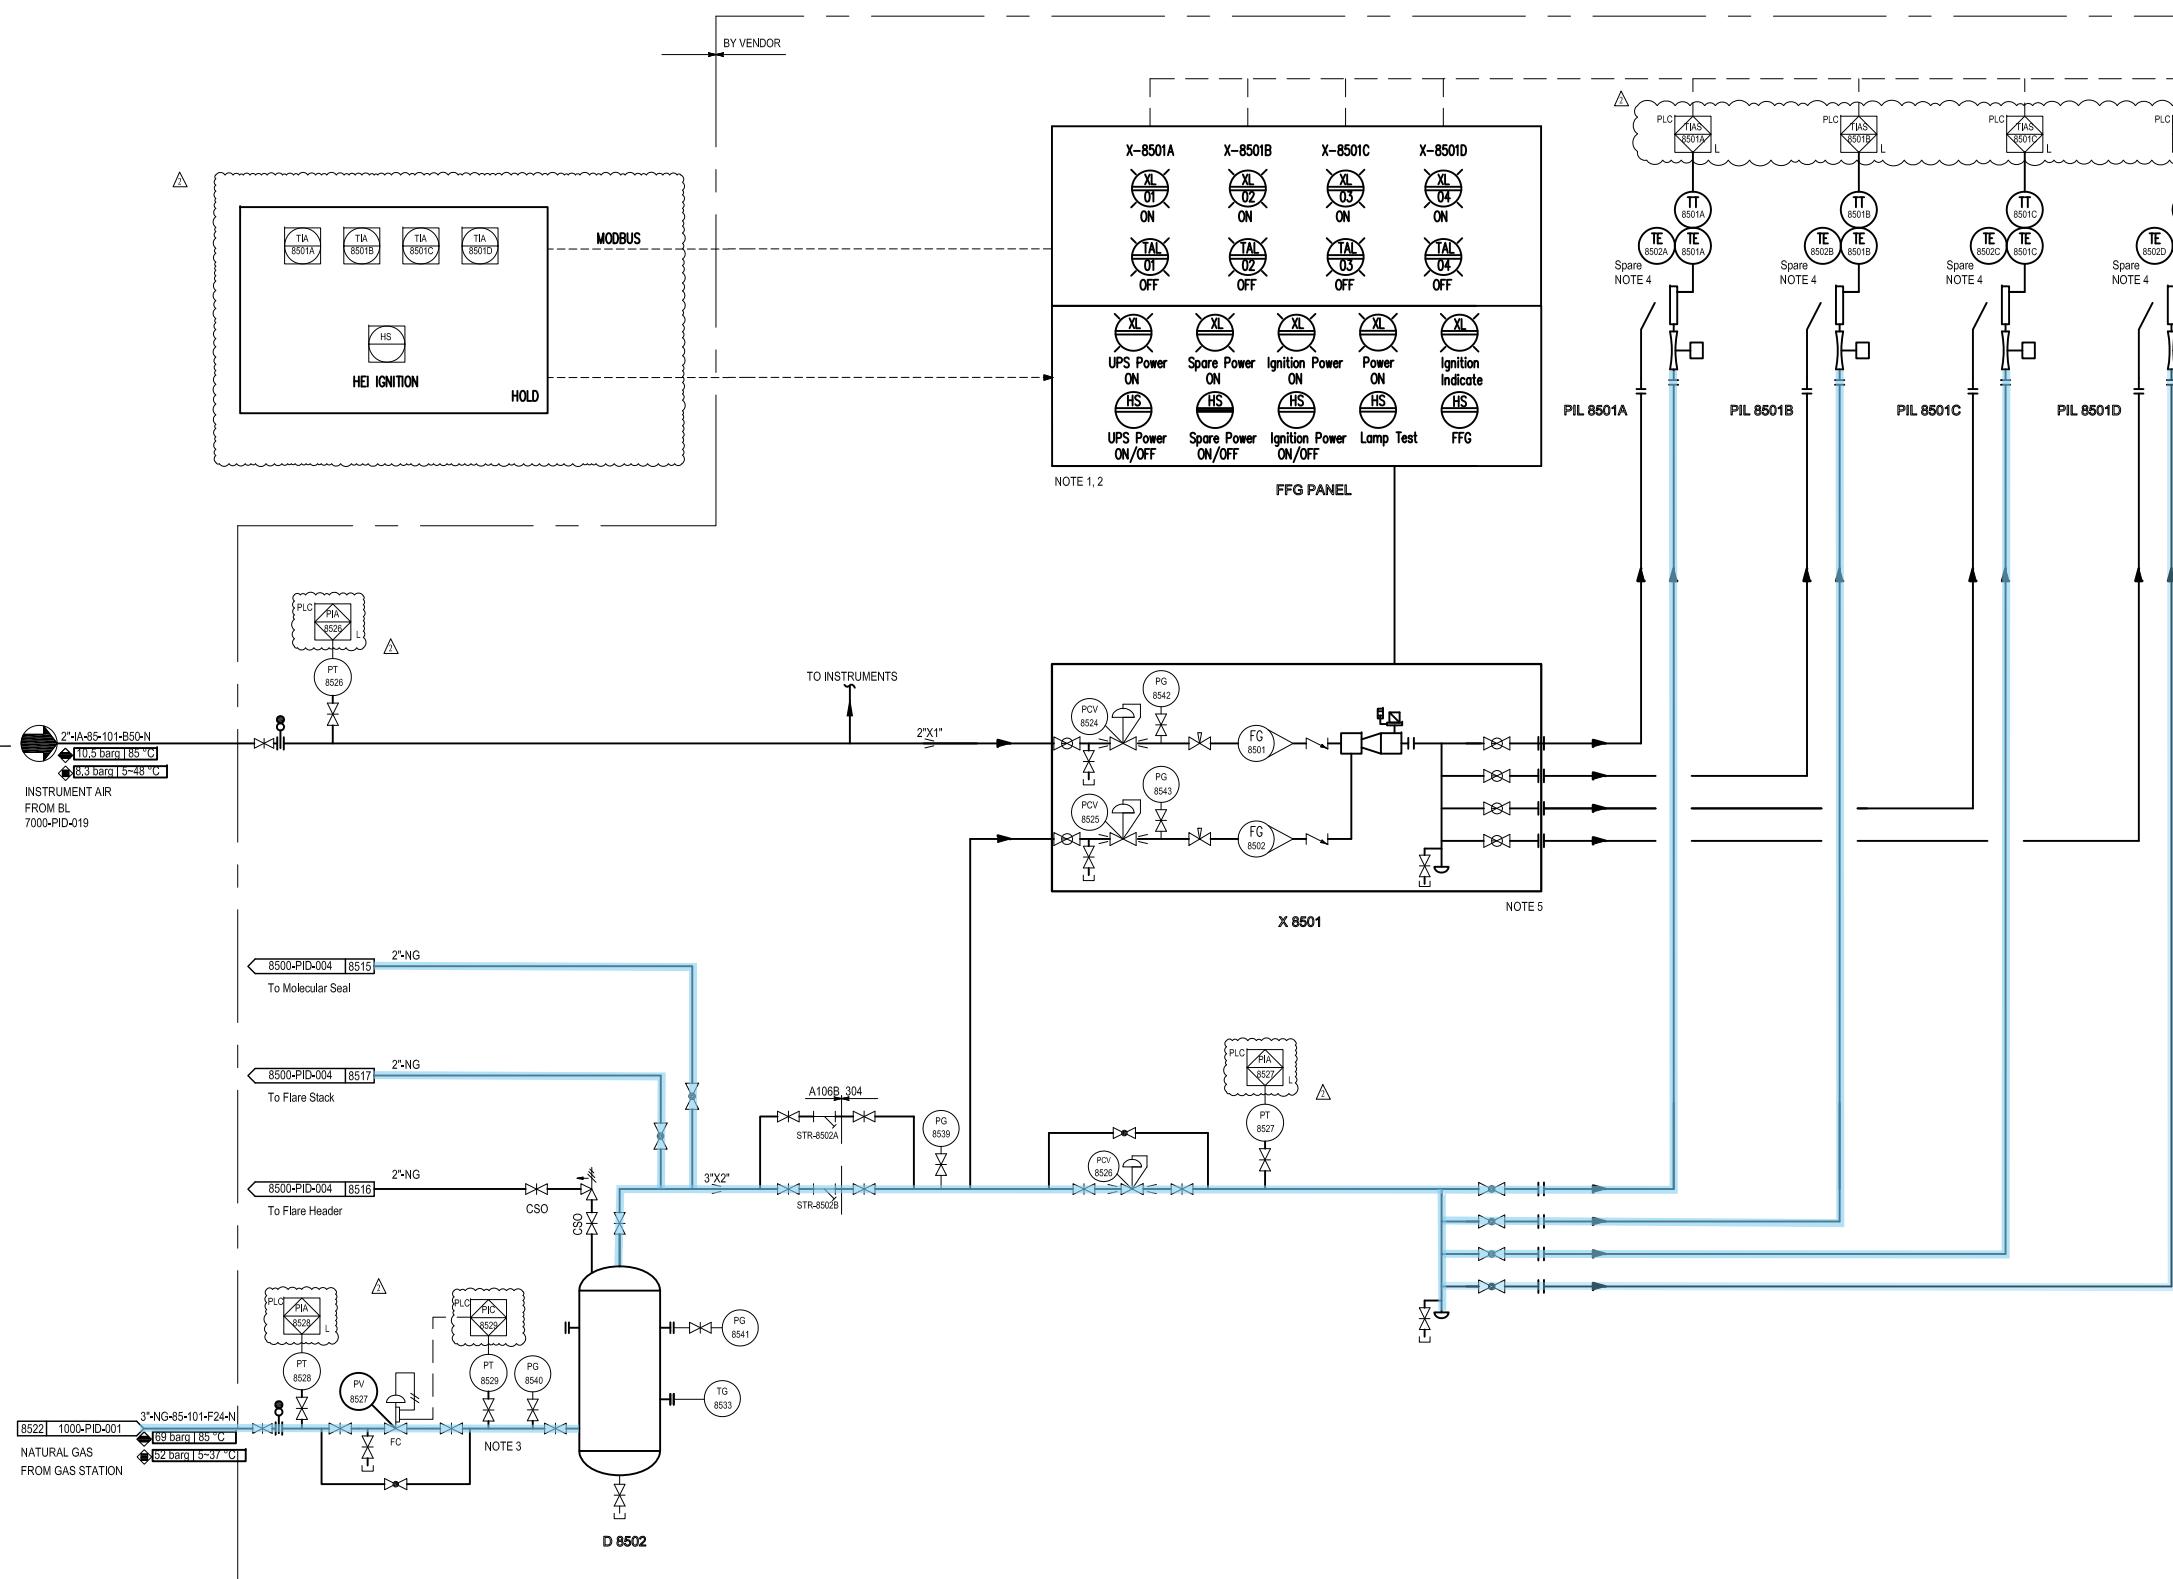
P&ID FLARE STACK II				PROJECT	MKP Methanol Project
				UNIT	Flare
				PHASE	Detail Engineering
Counter Signing	Sign	Date	SCALE: -	SHEET: 1	TOT.: 1
OWNER DWG NO.	MKP-11-DE-8500-PR-PID-005		SIZE: A1

+NOTE:
 1) XL-01-04: PILOT CONDITION INDICATION LAMP, WHEN PIL-8501A/B/C/D ARE IN NORMAL CONDITION, THE RELEVANT LAMP IS ON.
 2) TAL-01-04: PILOT TEMPERATURE LOW ALARM LAMP, WHEN THE TEMPERATURE OF ANY ONE IN PIL-8501A/B/C/D IS LOWER THAN 150°C, THE RELEVANT LAMP IS ON.
 3) PIPE PRESSURE AFTER PRESSURE REDUCING VALVE SHALL BE VERIFIED DURING DETAILED ENGINEERING PHASE.
 4) THERMOCOUPLE IS THE K TYPE DUAL SHEATH THERMOCOUPLE, ONE IS DUTY, ANOTHER ONE IS SPARE.
 5) FFG WILL BE SUPPLIED AS THE COMPLETE SUPPLY SET BY VENDOR.

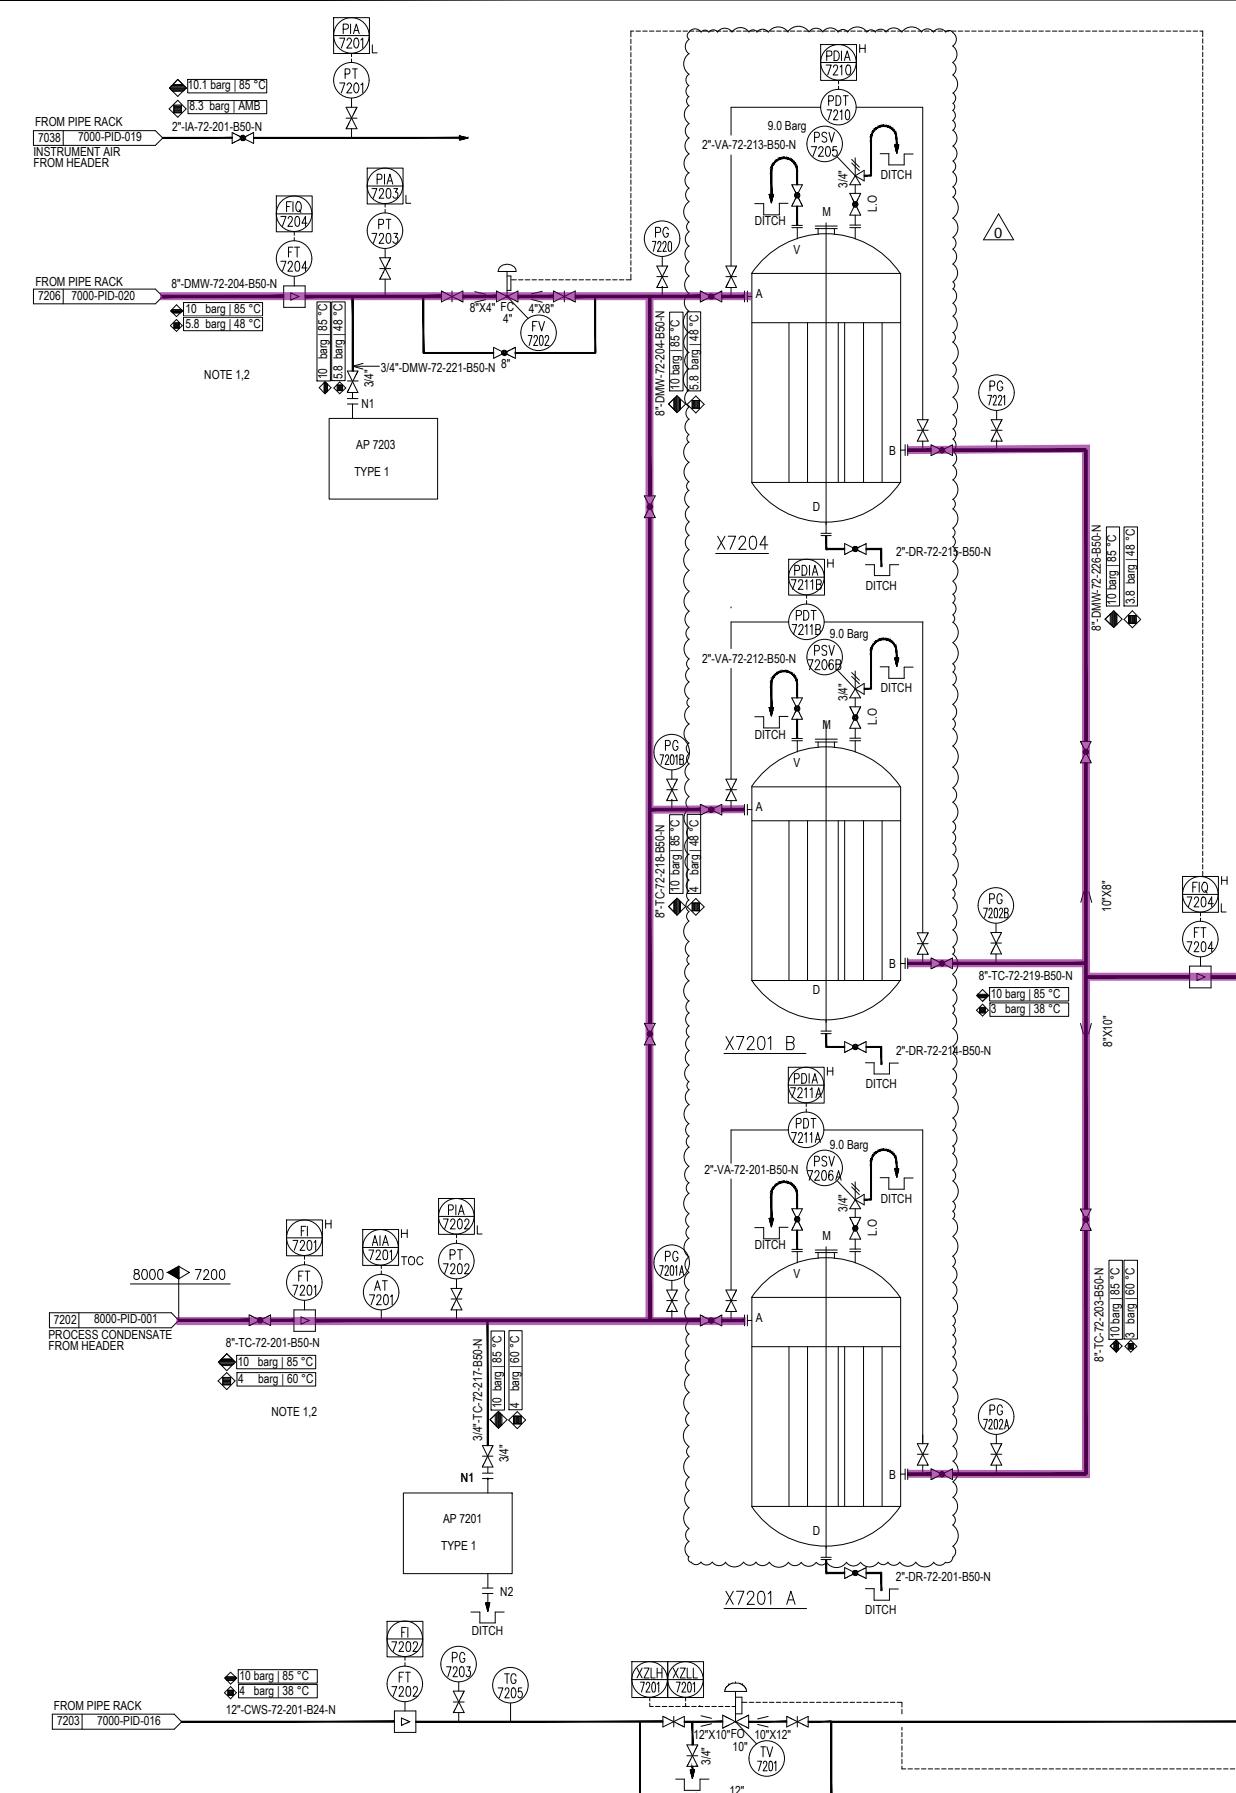
FILTER AND HEAT EXCHANGER P&ID FOR POLISHING UNIT			
PROJECT	MKP Methanol Project	UNIT	POLISHING UNIT
PHASE	DETAIL ENGINEERING	OWNER	Kimiaye Pars Company
SCALE	-	SHEET 1	TOT. 1
OWNER DWG NO.	MKP-11-DE-7200-PR-PID-001	SIZE A1

E 7201 A/B	PLATE HEAT EXCHANGER	X 7201 A	CARTRIDGE FILTER	X 7201 B	CARTRIDGE FILTER	X 7204	CARTRIDGE FILTER
EXCHANGE AREA	280 m ²	CAPACITY	150 m ³ /h	CAPACITY	150 m ³ /h	CAPACITY	150 m ³ /h
DESIGN PRESS.	10 barg	ID x HEIGHT	1000 x 1500 mm	ID x HEIGHT	1000 x 1500 mm	ID x HEIGHT	1000 x 1500 mm
DESIGN TEMP.	85 °C	DESIGN PRESS.	10 barg	DESIGN PRESS.	10 barg	DESIGN PRESS.	10 barg
TYPE	PLATE	DESIGN TEMP.	85 °C	DESIGN TEMP.	85 °C	DESIGN TEMP.	85 °C
MATERIAL	SS304	MATERIAL CASING	C+S+R.L	MATERIAL CASING	C+S+R.L	MATERIAL CASING	C+S+R.L
INSULATION	NONE	MATERIAL FILTER ELEMENT	PP	MATERIAL FILTER ELEMENT	PP	MATERIAL FILTER ELEMENT	PP
ELEV. OF FOUNDATION	EL 100.80 m	INSULATION	NONE	INSULATION	NONE	INSULATION	NONE

GENERAL NOTES																																																											
NOTE 1: POLISHING UNIT IS GENERALLY REVISED BECAUSE DMW WATER FROM DAMAVAND NEEDS TO BE POLISHED, THE CAPACITY OF POLISHING UNIT WAS REVISED FROM 126 M3/H TO 250 M3/H. THE DRAWING IS ONLY FOR REFERENCE. VENDOR SHALL FINISH THE DETAILED DESIGN OF THIS DRAWING AND APPROVED BY TCC.					A																																																						
NOTE 2: POLISHING UNIT SHOULD BE PACKAGE SUPPLIED, INCLUDING ALL THE EQUIPMENT, PLC, INSTRUMENT, CONTROL VALVE SHOWN IN P&ID, MOTORS AND PUMPS. THE MAIN PROCESS P7002 A/B, M7002 AB, TK7201 AND T7K001 1/2 WITH LEVEL TRANSMITTER AND GAUGE SHALL BE IN TCC'S WORKING SCOPE.					B																																																						
REFERENCE DRAWINGS																																																											
SYMBOLS AND LEGENDS																																																											
KEY PLAN

Serial #	Deviation	Cause	Consequence	Safeguard	Severity	Likelihood	Risk	LOPA	Recommendation
7201 . 1	High flow(DMW inlet)	1 1.DMW from BL high flow. 2.FV-7202 fail. 3.FV-7202 bypass valve abnormally open due to human error .	1.TK-7201 high level and flood. 2.High consumption of DMW.	1.LT/LIA-7201 high level alarm. 2.Overflow line.	3	3	2	N	
. 2	High flow(DMW outlet)	1 1.P-7201 A/B standby pump abnormally start. 2.FV-7091 fail open.	1.TK-7001 1/2 low level and P-7002 A/B damage. 2.D-7001 high level. Refer to node 7004 high level(D-7001). 3.DMW to deaerator temperature decrease and low deaerator efficiency.	1.LT-7202A/B low level alarm, low low level alarm and stop the P-7002A/B. 2.FIC-7091 high flow alarm. 3.FI-7205 flow indicator. 4.TV-2457 and TE-2457 control the temperature.	3	3	2	N	
. 3	High flow(condensate inlet)	1 1.High flow in upstream.	1.X-7201A/B and X-7204 high d/p and running period decrease. 2.High temperature of X-7201A/B and X-7204. 3.TK-7201 high level.	1.PDIA-7210/7211A/B high d/p alarm. 2.LIA-7201 high level alarm. 3.Overflow line TK-7201. 4.LICA-7202 A/B high level alarm. 5.FV-7202.	3	3	2	N	1.Add a temperature transmitter and send the signal to control room, set high alarm in the 8"-TC-72-201-B50-N inlet line of X-7201A/B and X-7204.

. 4	High flow(R-7201A/B inlet)	1 1.P-7201 A/B standby pump abnormally start.	1.Overflow of R-7201A/B.	1.FT-7203A/B. 2.PDT-7207/8 high alarm.	3	3	2	N	
. 5	low/no flow(DMW inlet)	1 1.Low/no flow in upstream. 2.FV-7202 fail closed.	1.TK-7201 low level and P-7201A/B cavitation and damage.	1.FT/FIQ-7204 alarm. 2.LICA-7201 low level alarm. 3.LALL-7201 activate I-721 to trip P-7201A/B.	4	3	3	N	1.Change FIQ-7204 to FI-7204.

Serial #	Deviation	Cause	Consequence	Safeguard	Severity	Likelihood	Risk	LO PA	Recommendation
. 6	low/no flow(DMW outlet)	1 1.P-7002 A/B failure. 2.P-7002 outlet manual valve abnormally closed due to operator error. 3.FT/FIC/FV-7091 fail closed. 4.TK-7001 1/2 outlet manual valve abnormally closed due to operator error. 5.ARV in the discharge of pump fail and return maximum possible flow back to TK-7001 1/2.	1.TK-7001 A/B high level and flood. 2.Refer to node 7004 low flow(DMW). 3.Low/no flow of BFW in downstream especially steam drum. 4.P-7002 A/B cavitation and damage.(in the case of cause 4)	1.P-7002 A/B 1 operate 1 spare. 2.FI-7205 flow indicator. 3.LICA-7202 A/B high level alarm. 4.Refer to node 7004 low flow(DMW).	3	3	2	N	1.Add low alarm for FT-7205.
. 7	low/no flow(condensate inlet)	1 1.Low/no flow in upstream,C-3001/2 FT-3001 shutdown. 2.Human error in closing manual valve. 3.X-7201A/B and X-7204 blocked. 4.E-7201 A/B blocked.	1.TK-7201 low level and P-7201 A/B cavitation and damage.	1.FI-7201 flow indicator. 2.LIA-7201 low level alarm. 3.LALL-7201 activate I-721 to trip P-7201A/B. 4.X-7201 standby. 5.E-7201 A/B, 1 operate 1 spare. 6.PT-7203/7202 low alarm. 7.PDT-7210/11A/B high d/p alarm.	3	3	2	N	1.Add low alarm for FI-7201. 2. Add FI and low alarm for FI-7204 (DMW from B.L)

. 12	high pressure(condensate)	1 1.X-7201A/B,X-7204 blockage. 2.Human error in operating both P-3011A/B at the same time.	1.Overpressure damage equipment and pipe.	1.PT-7202 indicator. 2.PSV-7206A/B and PSV-7205 @9bar.	3	3	2	N	1.Add alarm high for PT-7202. 2. Correct setpoint of PSV-7205 and PSV-7206A/B to 10 barg.
. 13	high pressure(DMW)	1 1.X-7201A/B,X-7204 blockage. 2.High pressure in upstream.	1.Overpressure damage equipment and pipe. 2.Back pressure to P-3011A/B.	1.PT-7203 indicator. 2.PSV-7206A/B and PSV-7205 @9bar. 3.Check valve on discharge of P-3011A/B.	3	3	2	N	1.Add alarm high for PT-7203. 2.Correct setpoint of PSV-7205 and PSV-7206A/B to 10 barg.

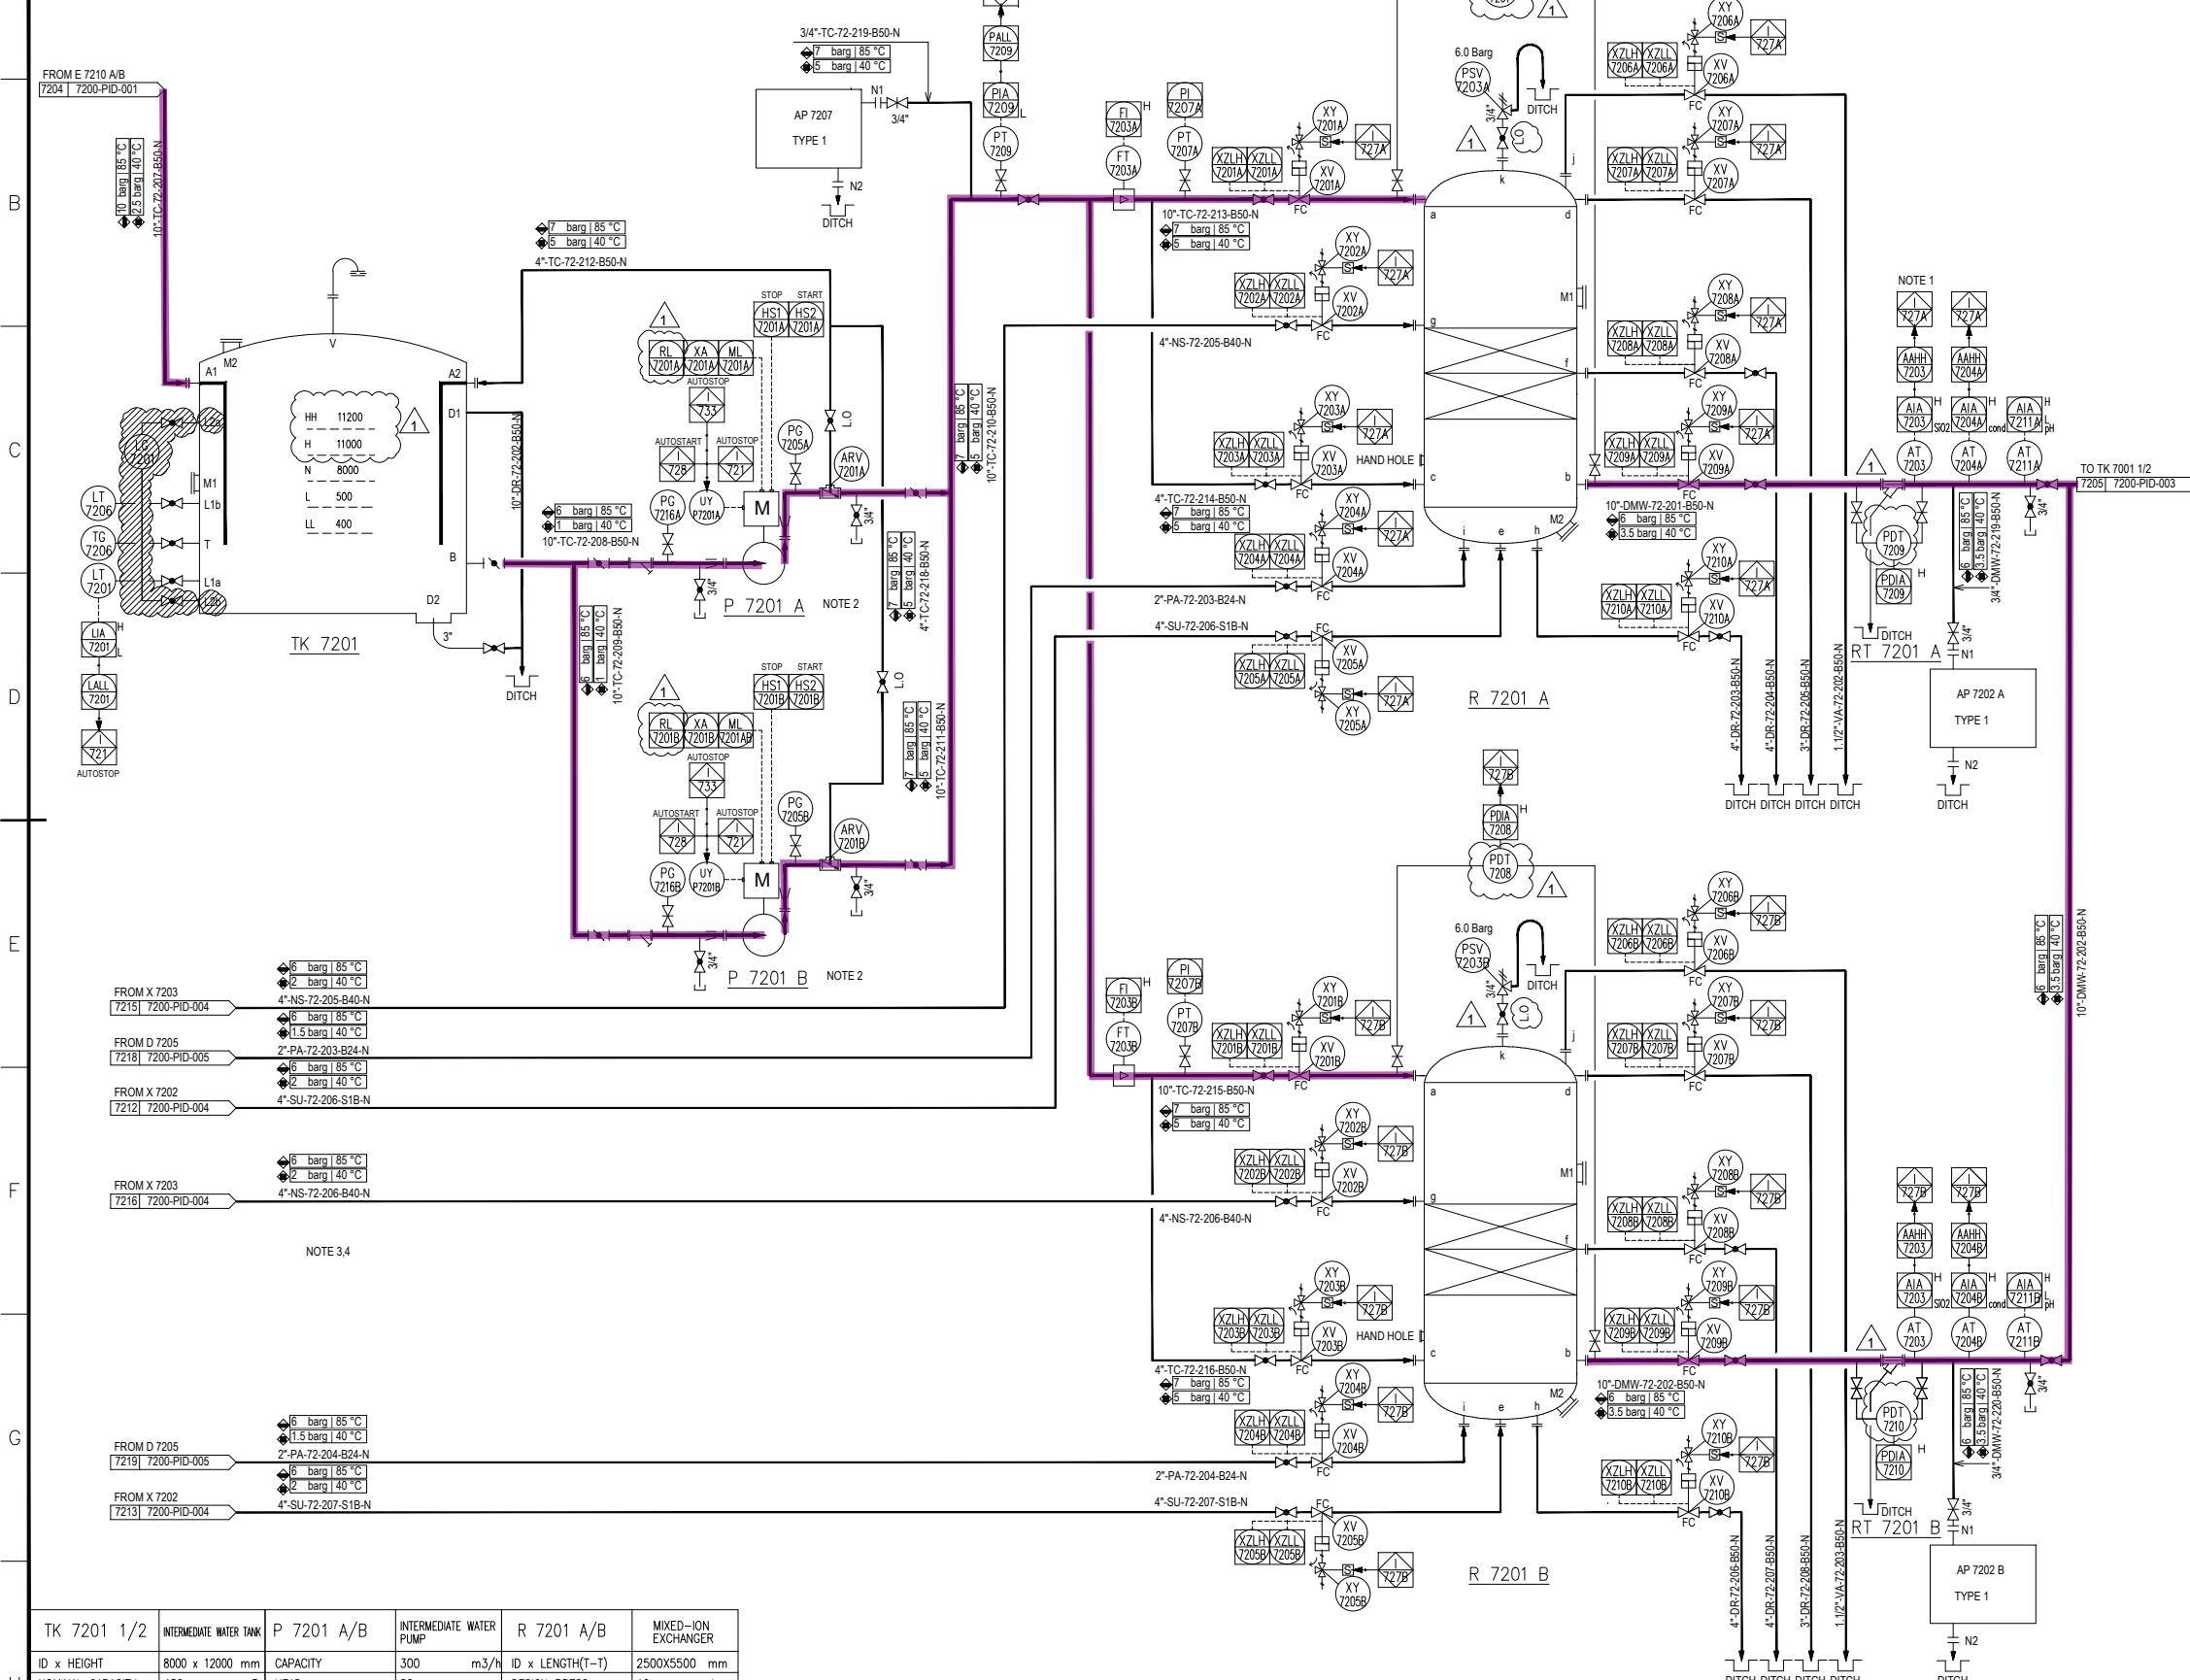
TK 7201 1/2	INTERMEDIATE WATER TANK	P 7201 A/B	INTERMEDIATE WATER PUMP	R 7201 A/B	MIXED-ION EXCHANGER
ID x HEIGHT	8000 x 12000 mm	CAPACITY	300 m3/h	ID x LENGTH(T-T)	2500X5500 mm
NOMINAL CAPACITY	450 m3	HEAD	50 m	DESIGN PRESS.	10 barg
DESIGN PRESS.	ATM	DENSITY@OT	992.2 kg/m3	DESIGN TEMP.	85 °C
DESIGN TEMP.	85 °C	INSULATION/TRACING	NONE	INSULATION	NONE
INSULATION	NONE	AUXILIARY PIPING	By Vendor	MATERIAL	C.S.
MATERIAL	SS304	TYPE	CENTRIFUGAL	CLADDING/LINING	RUBBER
ELEV. OF FOUNDATION	EL 100.80 m	MATERIAL	SS304	ELEV. OF FOUNDATION	EL 100.80 m
		ELEV. OF FOUNDATION	EL 100.80 m

. 8	low flow (R-7201A/B inlet)	1 1.P-7201A/B failure. 2. Manual valve abnormally close.	1.TK-7001 1/2 low level.	1.LT-7202A/B low level alarm. 2.FT-7203A/B indicator. 3.Auto start P-7201A/B by PT-7209.	2	4	2	N	1.Add low alarm for FT-7203A/B.

Serial #	Deviation	Cause	Consequence	Safeguard	Severity	Likelihood	Risk	LOPA	Recommendation
. 14	high pressure(R-7201A/B)	1 1.R-7201A/B blocked; 2.XV-7209A/B abnormally closed. 3. P-7201A/B start at the same time.	1.Damage of R-7201A/B. 2.Low Mixed bed efficiency.	1.PSV-7203A/B @6bar. 2.PT-7207A/B indicator.	3	4	3	N	1.Add alarm high for PT-7207A/B. 2. Correct setpoint of PSV-7203A/B to 7 barg.
. 15	high pressure(DMW to user)	1 1.P-7002A/B start at the same time. 2.Closed failure of FV-7091.	1.High pressure of E-2025 shell side.	1.PSV-2458 @14 barg.	2	3	1	N	1.Correct design pressure of discharge line from P-7002A/B to 14 barg.
. 16	low pressure(Condensate)	1 1.Low pressure due to P-3011A/B failure.	1.Low level of TK-7201.	1.PT/PIA-7202 low pressure alarm. 2.PT/PAL-3584 low pressure alarm.	3	2	1	N	
. 17	low pressure(DMW)	1 1.Low pressure in B.L.	1.Low level of TK-7201.	1.PT/PIA-7203 low pressure alarm.	3	2	1	N

. 18	low pressure(R-7201A/B)	1 1.P-7201A/B failure.	1.Low level of TK-7001 1/2.	1.PT/PIA-7209 low alarm and low low auto start standby pump.	3	3	2	N	
. 19	low pressure(DMW to user)	1 1.P-7002A/B failure.	1.DMW supply failure.	1.PT/PIA-7204 low pressure alarm and low low auto start standby pump.	3	3	2	N	
. 20	vacuum	1 Not possible.						N	
. 21	high temperature	1 1.CW failure. 2.High temperature from upstream. 3.TE/TT/TIC/TV-7201 fail closed.	1.Process condensate temperature increased and resin failure. 2.Fe2+ and SiO2 carry over to downstream and affect steam quality and damage turbine. 3.Damage pump due to low NPSHa.	1.FI-7202 flow indicator. 2.AI-7203 high SiO2 alarm. 3.AI-7204A/B high conductivity alarm. 4.AAHH-7203,AAHH-7204A/B activate I-727A/B to regeneration.	4	3	3	N

. 24	high level(TK-7201)	1. XV-7201A/B failure. 2.XV-7209A/B failure. 3.P-7201A/B failure. 4.High flow in upstream.	1.TK-7201 overflow.	1.LIAH-7201 high level alarm. 2.Overflow line.	3	2	1	N	
. 25	high level(TK-7001 1/2)	1. Blockage of outlet. 2.P-7002A/B failure. 3.High flow in upstream.	1.TK-7001 1/2 high level and flood. 2.High consumption of DMW.	1.LICA-7202A/B high level alarm. 2.Overflow line.	3	2	1	N	
. 26	high level(PD-7206)	1.XV-7207~7210 A/B fail open after regeneration.	PD-7206 high level and may flood since liquid content is acid or base so environmental pollution or injury personnel is possible.	1.LIA-7205 high level alarm. 2.The pond is located in a curb.	3	4	3	N

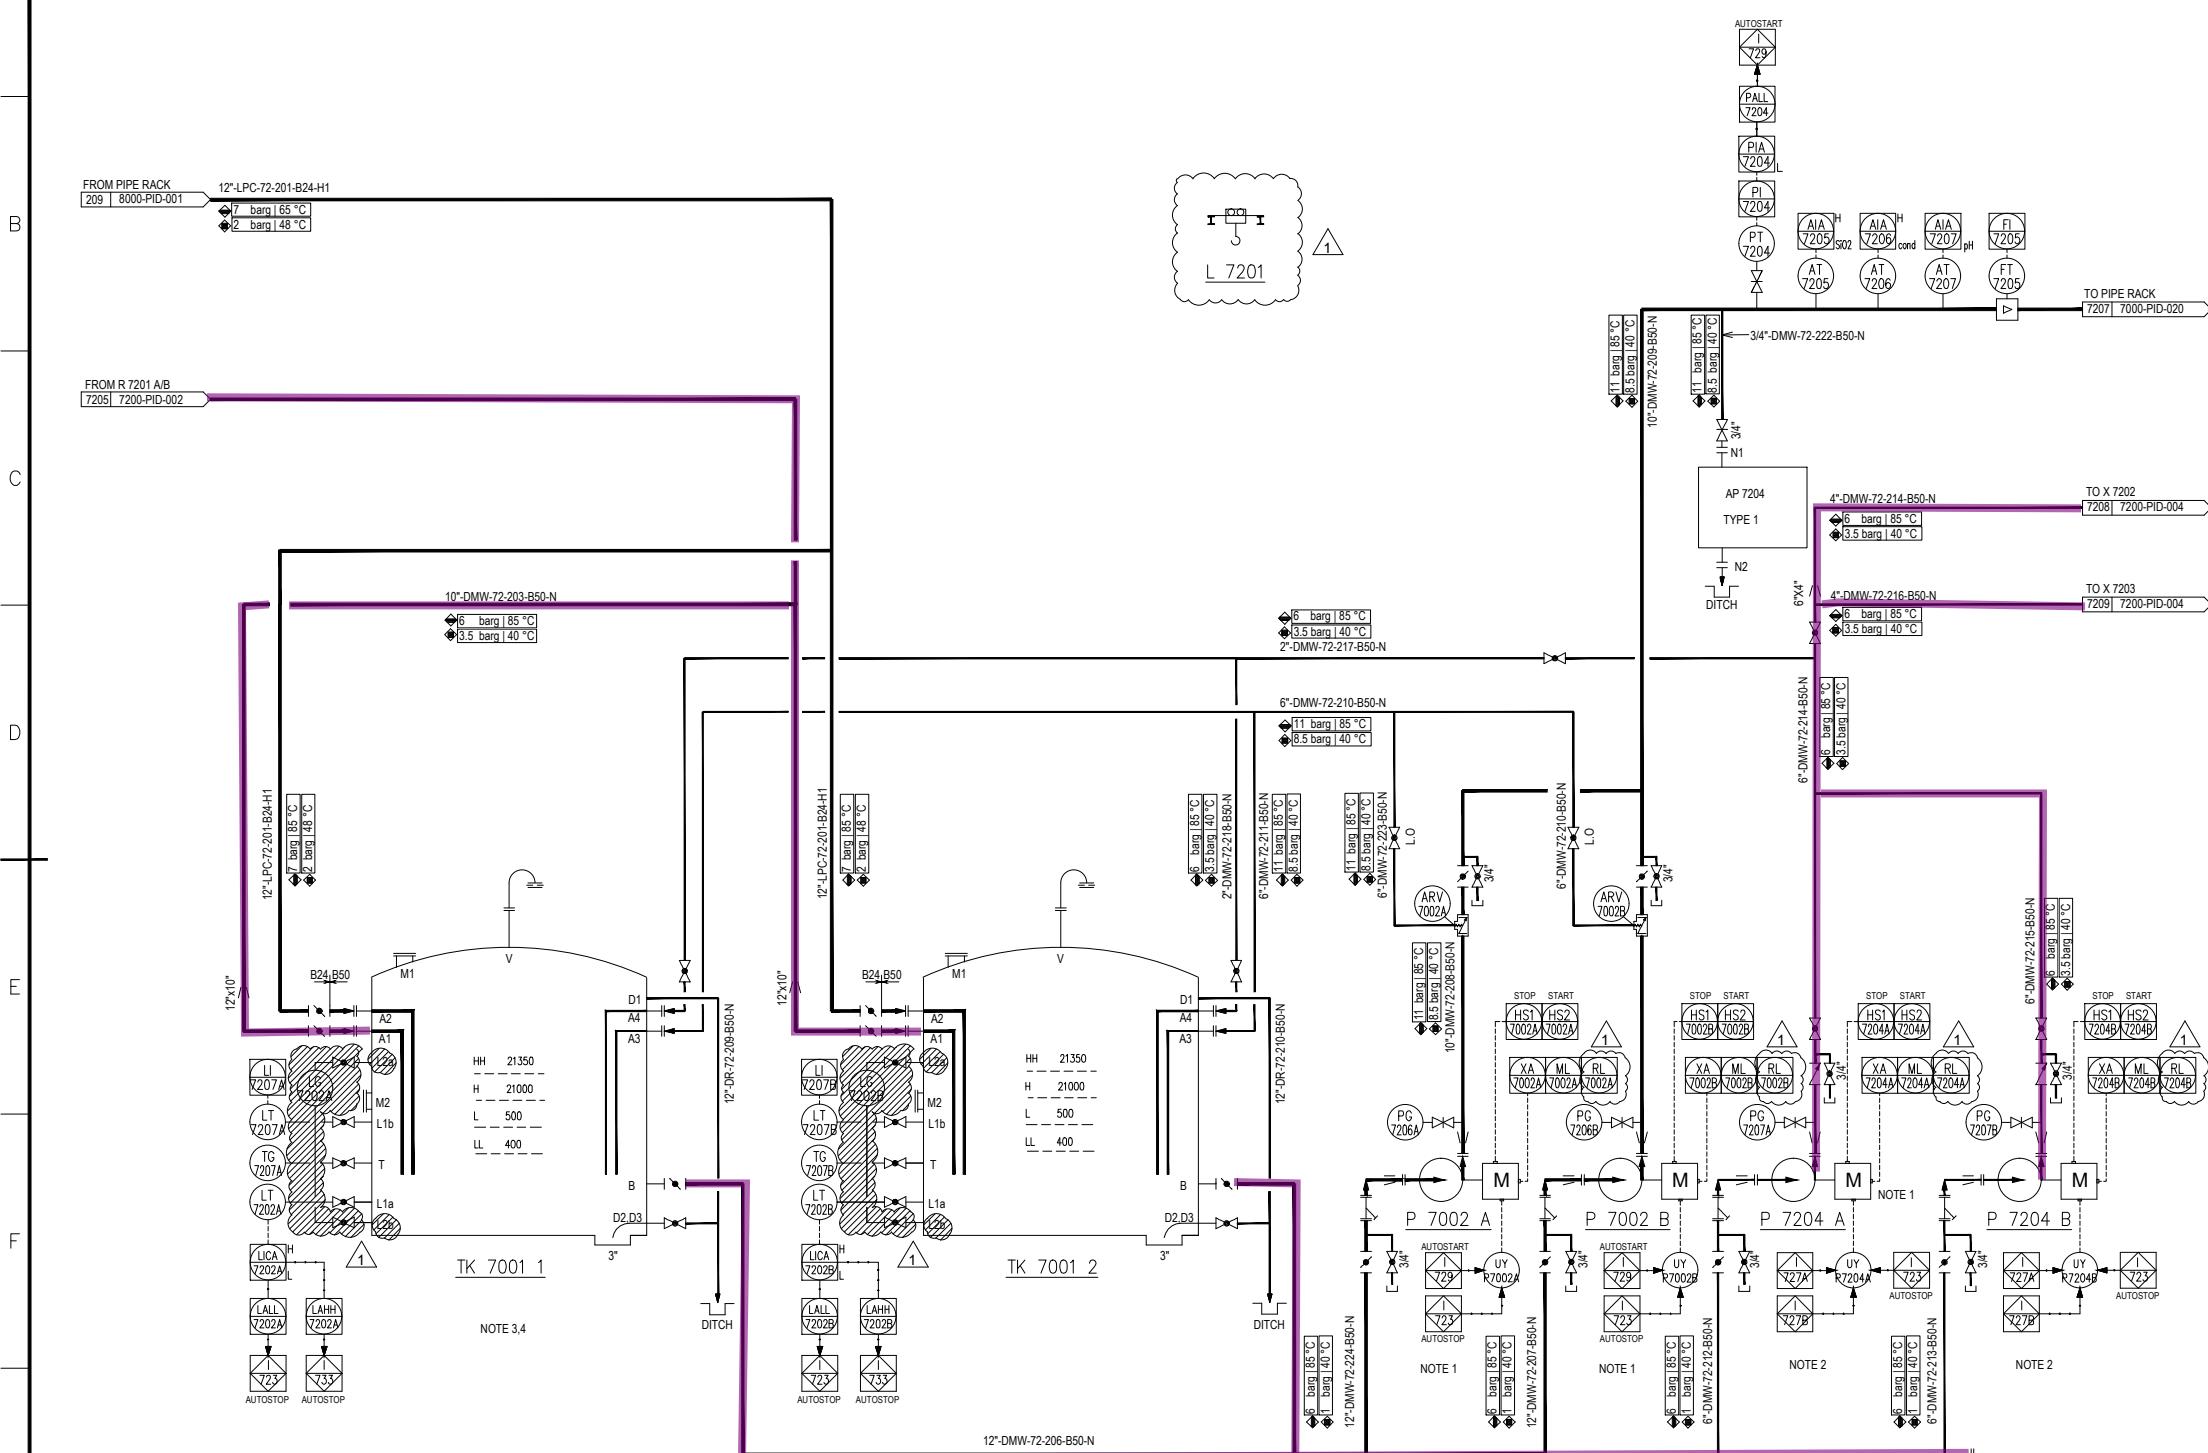
TK 7001 1/2	DEMIN WATER TANK	P 7002 A/B	DEMIN WATER PUMP	P 7204 A/B	REGENERATION PUMP	L 7201	HOIST
ID x HEIGHT	15000 x 22000 mm	CAPACITY	265 m ³ /h	CAPACITY	85 m ³ /h	TYPE	ELECTRICAL HOIST
NOMINAL CAPACITY	3500 m ³	HEAD	85 m	HEAD	35 m	CAPACITY	2 t
DESIGN PRESS.	barg	DENSITY@OT	992.2 kg/m ³	DENSITY@OT	992.2 kg/m ³	LIFT HEIGHT	4.5 m
DESIGN TEMP.	85 °C	INSULATION/TRACING	NONE	INSULATION/TRACING	NONE	SLIDING DISTANCE	41 m
INSULATION	NONE	AUXILIARY PIPING	By Vendor	AUXILIARY PIPING	By Vendor		
MATERIAL	SS 304	TYPE	CENTRIFUGAL	TYPE	CENTRIFUGAL		
ELEV. OF FOUNDATION	EL 100.80 m	MATERIAL	SS304	MATERIAL	SS304		
	ELEV. OF FOUNDATION EL 100.80 m	ELEV. OF FOUNDATION	EL 100.80 m	ELEV. OF FOUNDATION	EL 100.80 m

- NOTE 1: PUMP P7002 A/B AUTOSTARTS WHEN PRESSURE INDICATED ON PT-7204 IS 1 BAR.
- NOTE 2: PUMP P7204 A/B AUTOSTARTS WHEN REGENERATION PROCESS STARTS, STANDBY PUMP STARTS WHEN THE WORKING PUMP IS MALFUNCTIONING.
- NOTE 3: POLISHING UNIT IS GENERALLY REVISED BECAUSE DMW WATER FROM DAMAVAND NEEDS TO BE POLISHED, THE CAPACITY OF POLISHING UNIT WAS REVISED FROM 126 M3H TO 250 M3H. THE DRAWING IS ONLY FOR REFERENCE, VENDOR SHALL FINISH THE DETAILED DESIGN OF THIS DRAWING AND APPROVED BY TCC.
- NOTE 4: POLISHING UNIT SHOULD BE PACKAGE SUPPLIED, INCLUDING ALL THE EQUIPMENT, PLC, INSTRUMENT, CONTROL VALVE SHOWN IN P&ID, MOTORS AND PUMPS. THE MAIN PROCESS P7002 A/B, MP 7002 AB, TK 7201 AND TK 7001 1/2 WITH LEVEL TRANSMITTER AND GAUGE SHALL BE IN TCC'S WORKING SCOPE.

Serial #	Deviation	Cause	Consequence	Safeguard	Severity	Likelihood	Risk	LOPA	Recommendation
. 27	low/no level(TK-7201)	1 1.Low/no flow in upstream. 2.Human error in opening drain valve.	1.pump damage. 2.Low/no flow in downstream. 3.Loss of condensate.	1.LALL-7201 low low level activate I-721 trip P-7201A/B. 2.FI-7204 flow indicator.	3	3	2	N	
. 28	low/no level(TK-7001 1/2)	1 1.Low/no flow in upstream. 2.Human error in opening drain valve.	1.Pump damage. 2.Low/no flow in downstream, perhaps low/no of BFW.	1.LALL-7202A/B low low level activate I-723 to trip P-7002A/B, P-7204A/B. 2.FI-7205 flow indicator.	3	3	2	N	
. 29	low/no level(PD-7206)	1 Emptying the pond by manual turning on the pump.	1.Pump damage.	1.LIA-7205 low level alarm. 2.LALL-7205 low low level activate I-726 trip P-7205A/B.	2	4	2	N	
. 30	other	1						N	1.HAZOP study should be done by vendor for polishing unit package, the owner will check polishing unit package after receiving vendor data.
