Our Mistakes
Utility
PV-7002

# Educational Institute for Equipment and Process Design

## Problem

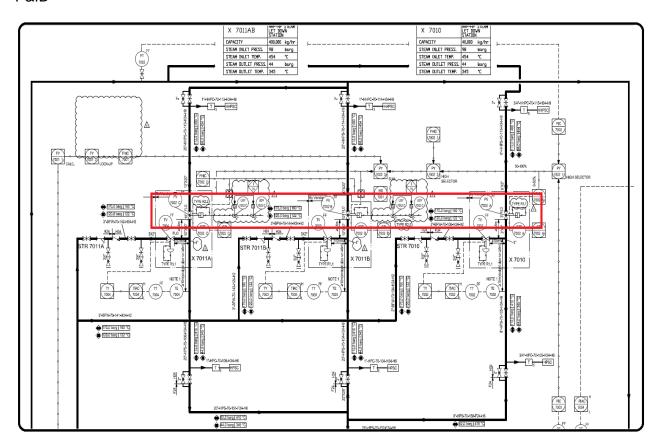
## P&ID

The opening of the valve abruptly changes.

Mechanical failure or instrumentation failure.

It impacts different steam system pressure.

Disassemble it to be checked in shop-for instance checking the stem or any object which might have caused the problem.

If not so, then improve the positioner brand as we did and the problem solved.
